TROUBLESHOOTING GUIDE

CFP-SP AWHB All Weather High Build

2020 Edition

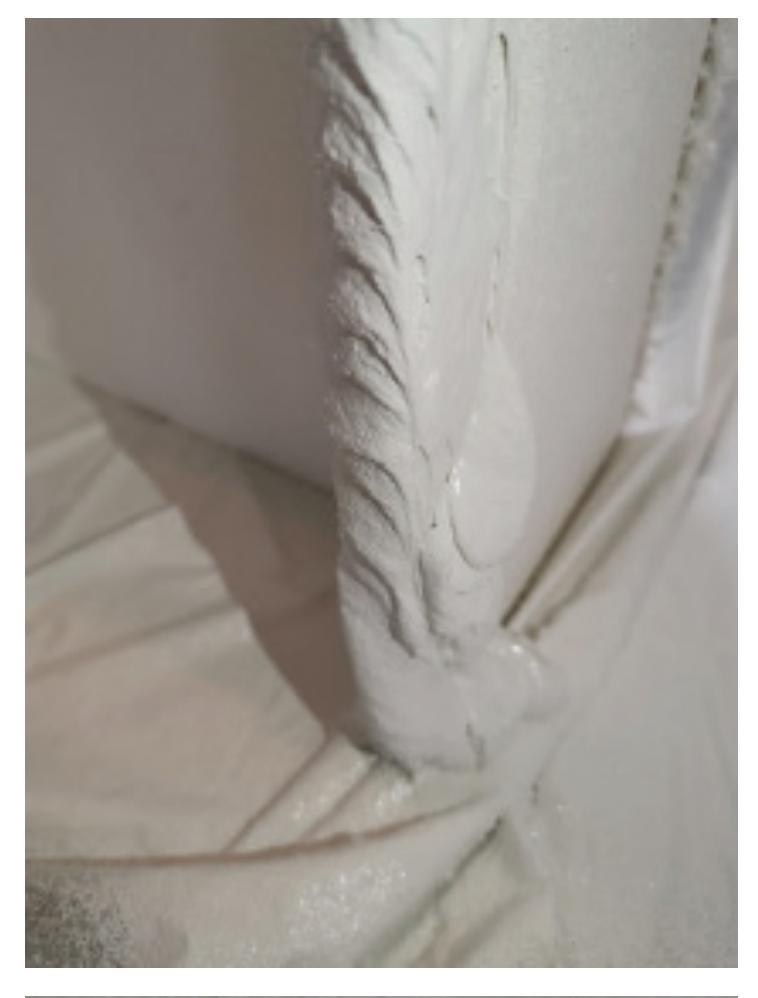
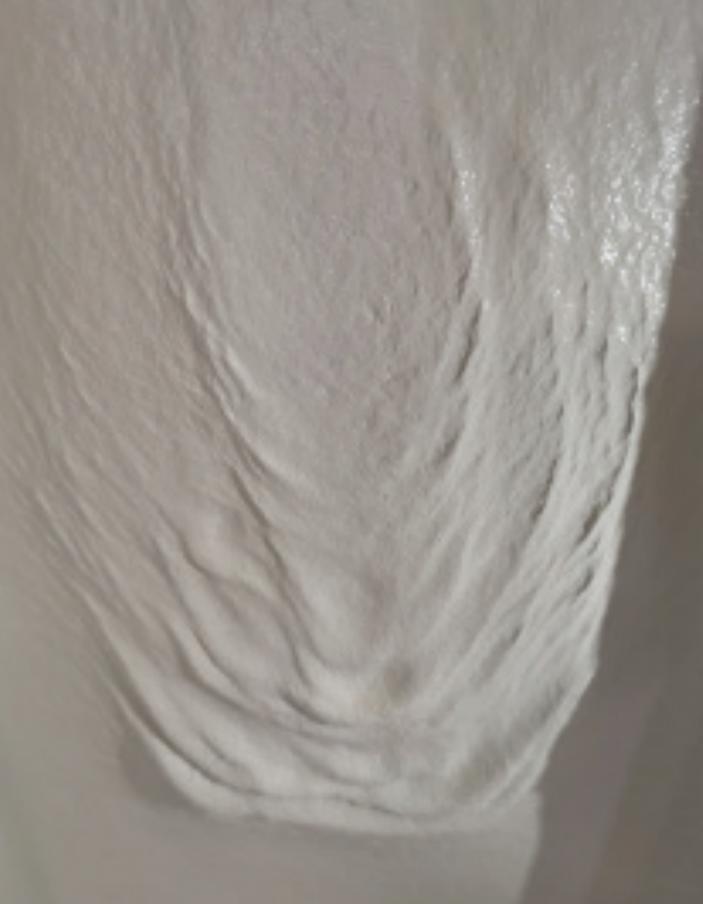
SAGGING

- Product appears to 'sag' down
- Often, beads of paint pool and run down the surface

- Applied Wet Film Thickness (WFT) significantly higher than recommended
- The product was thinned more than recommended
- Applicator stood too close to the structure during application

- No action required from a fire-safety perspective no detrimental effect on fire performance as long as required Dry Film Thickness (DFT) is met
- If superior aesthetics are required: sand to smooth surface (caution with DFT)

The maximum WFT per coat of AWHB is 350 mils.

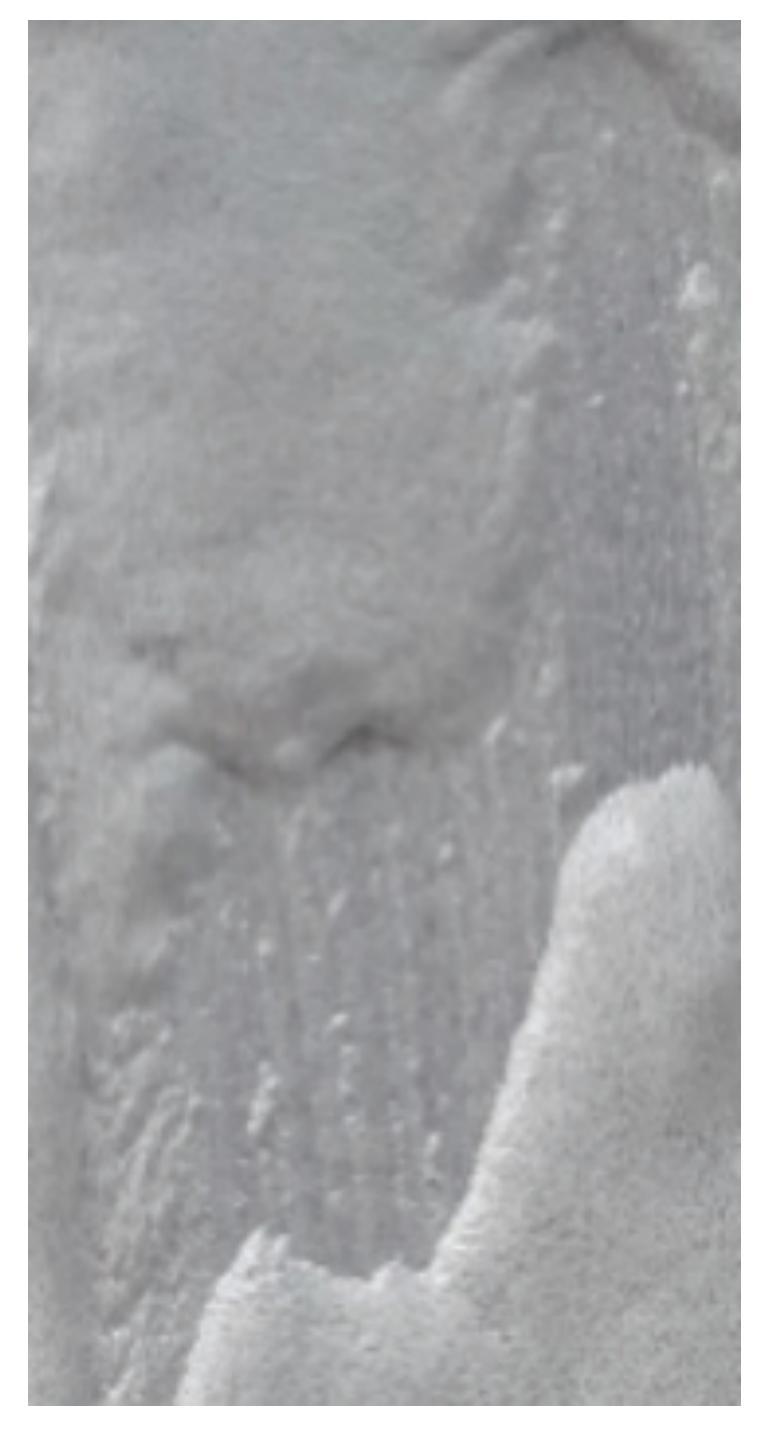
SLUMPING / SLIDING

• The intumescent fireproofing does not adhere to the substrate and slides down as a whole layer.

- Product applied on top of incompatible substrate/primer
- Surface contamination or presence of water on substrate, leading to improper adhesion

Complete removal of the coating

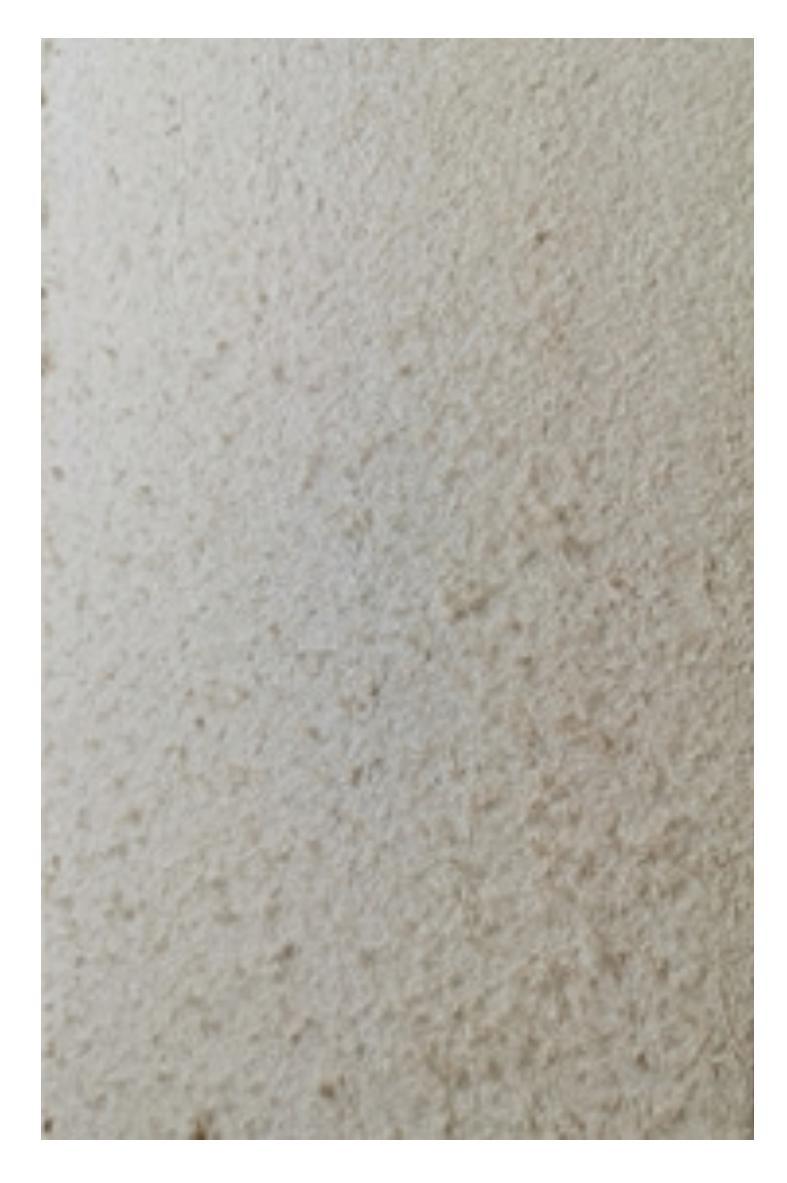
DRY SPRAY

· Poor atomization of intumescent material

- Applicator stood to far from structure during application
- Application temperature too high and/or humidity too high
- Pump pressure too high

- Nothing required from a fire-safety perspective no detrimental effect on fire performance as long as required DFT is achieved
- Ensure pump pressures are within recommendations by manufacturer/in Hilti application guide
- Ensure you are at a correct spraying distance from the surface, and within product spray parameters
- If superior aesthetics are required: sand to smooth surface maintaining proper DFT

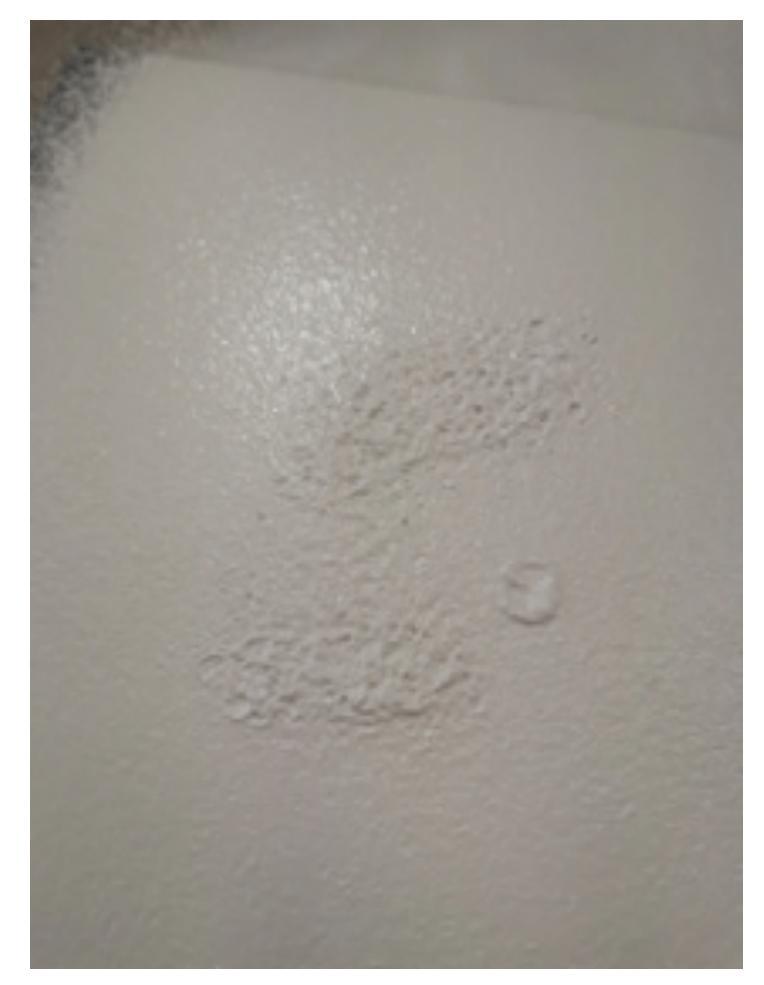
SURGES

• Intumescent material that sprays out from pump in a stream vs. an atomized spray fan

- Cavitation of the pump
- Short tip blockage
- Cured material inside the pump

- Cavitation: ensure sufficient level of intumescent in the pump feed
- Ensure that all connections of the pump are tight, and there is no air entering the pump
- Ensure that there is no dry or cured material inside the pump that can create an uneven flow
- No repairs required from a fire-safety perspective no detrimental effect on fire performance
- If superior aesthetics are required: sand to smooth surface maintaining proper DFT

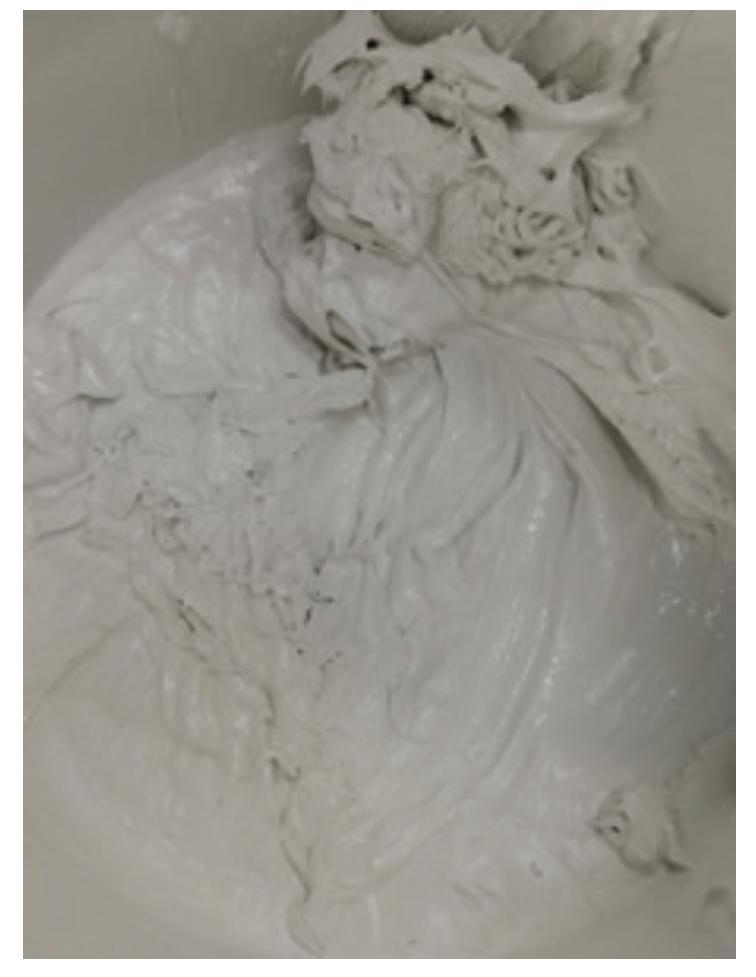
SKIN FORMATION

• A skin layer of cured product can appear at the top of the bucket

- Due to the unique chemistry of the product that cures with the moisture of the air, a skin layer of cured material can appear at the top of the bucket
- At high temperature and humidity, the skin layer will appear sooner

• In order to avoid issues while spraying, it is very important to remove the skin layer with a spatula

To prevent the formation of skin layer you can use one of the following methods:

- Cover the intumescent material in the bucket / hopper with a very thin layer of Xylene. Please note that this may result in slight dilution, especially if incorporated into the material, with the resultant impact on the material and spraying.
- Cover the material directly with a thin plastic sheet or film. Please ensure that the plastic sheet is clean and dry to ensure that it does not interact with the intumescent coating.

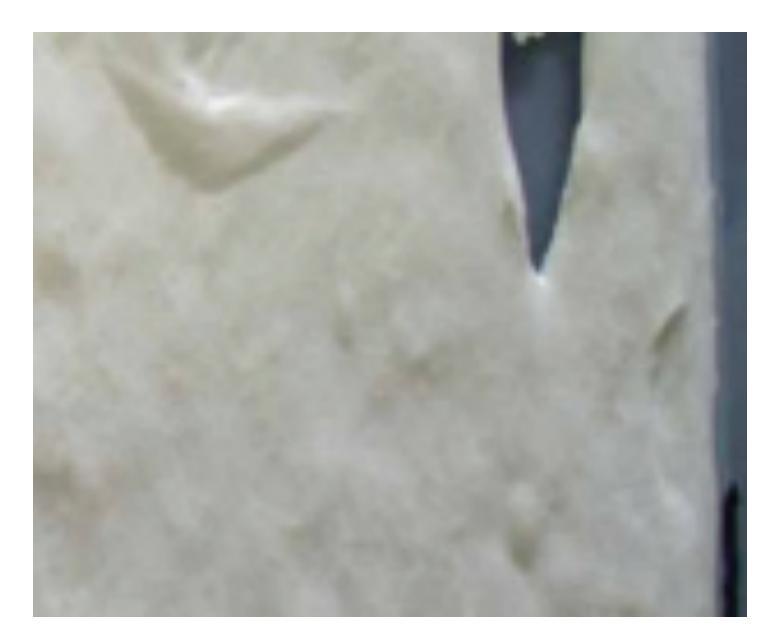
INCOMPATIBLE PRIMER — ADHESION PROBLEMS

The Hilti AWHB does not adhere to the substrate — slides off during the initial spraying / curing process or flakes when dry.

- The primer may not be compatible
- The product was applied outside of the specified recoat window of the primer
- Contamination or wet of substrate

- The Hilti AWHB product MUST be removed completely from the steel member
- Check primer compatibility (ask Hilti Technical service for approved primers list)
- Remove incompatible primer
- Remove contamination of the steel
- Apply approved primer
- Re-apply Hilti AWHB as per UL requirements

- The Hilti AWHB product MUST be removed completely from the steel member
- Remove primer
- Re-apply primer within the specs (check PDS of primer manufacturer for details)
- Re-apply Hilti AWHB as per UL requirements

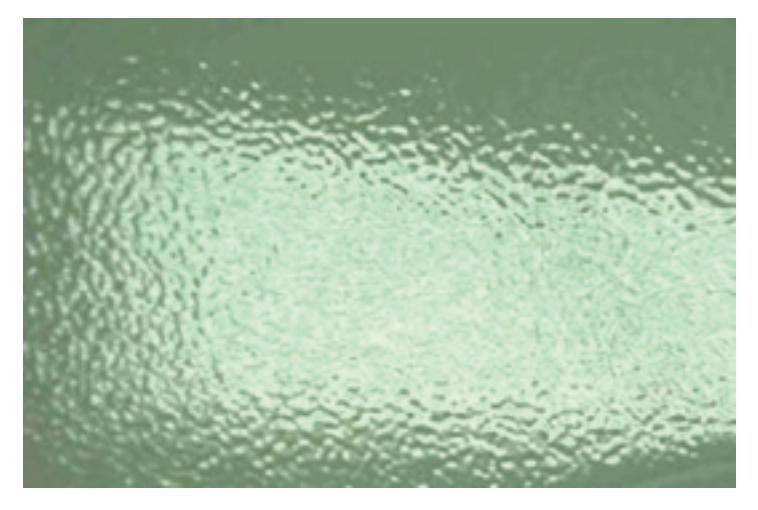
ORANGE PEEL

• Rough textured appearance, similar to the peel of an orange, on the surface of the product

- Normal appearance for high build coatings
- High WFT have a propensity to orange peel
- · High gloss topcoat exacerbates the appearance

- No repairs required from a fire-safety perspective no detrimental effect on fire performance
- If superior aesthetics are required: sand to smooth surface maintaining proper DFT

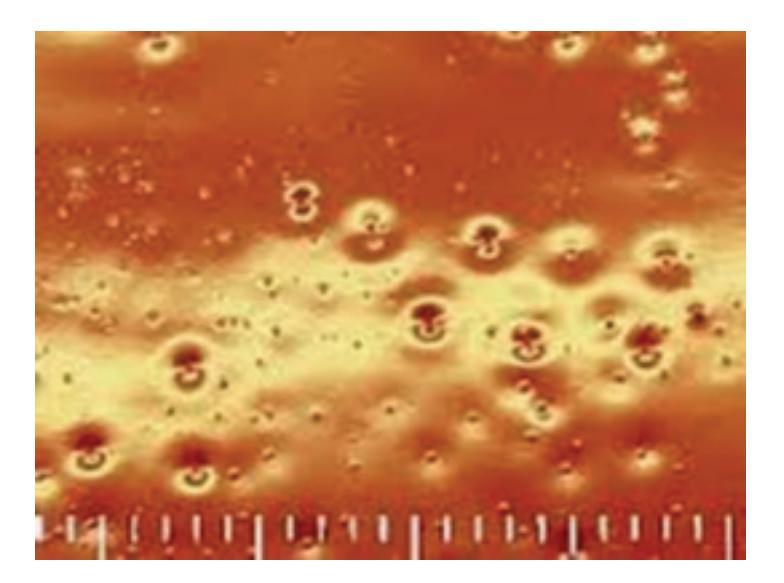
CRATERING (TOPCOATS ONLY)

Pock-marked topcoat (picture on the right)

- Defect in the topcoat caused by foreign matter
- Frequently observed with polyurethane and silicone topcoats
- NOT a problem of the intumescent

- Ensure that topcoat is properly mixed. When in doubt, filter the topcoat (see recommendations of the topcoat manufacturer)
- For continued issues, contact topcoat manufacturer
- No repairs required from fire-safety perspective no detrimental effect on fire performance
- If superior aesthetics are required: smooth topcoat and re-apply a thin layer

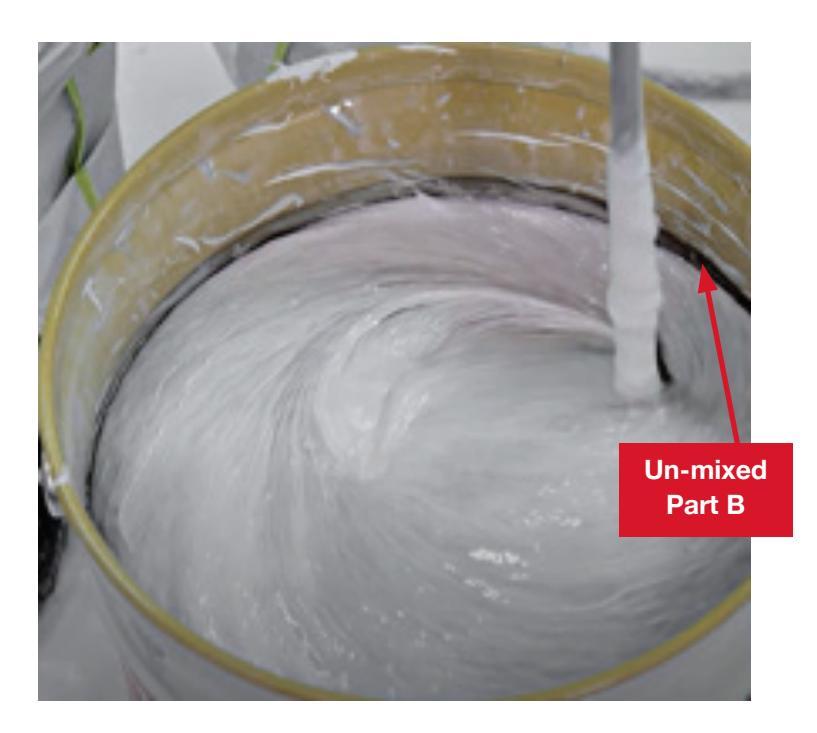
WRONG MIXING

- Uncured material (if no part B added)
- Unevenly cured areas.

- Forgetting to add Part B to Part A
- Not mixing full kit
- Component A and B have not been mixed properly

- The product must be completely removed and reapplied.
- To ensure proper mixing, the following steps must be followed:
 - Mix Part A thoroughly with a drill type mixer until homogeneous (>= 1 minute)
 - Shake part B can thoroughly before opening (>= 1 minute)
 - Pour ALL Part B into Part A bucket, and mix thoroughly with a drill type mixer until homogenous (>= 1 minute)
 - Note: Ensure that ALL the Part B product is fully mixed into Part A. Unmixed traces of Part B might stay at the sides of the tin (see picture right), please mix it all until all Part B is fully incorporated. Ensure that you only utilize full kits.
 - It is possible to open and pre-mix Part A before utilizing; however, Part B should be utilized IMMEDIATELY after opening, as it is extremely moisture sensitive.
