FIRE FINISH 60+ CFP-SP WB FIRE FINISH 120+ CFP-SP WB

Troubleshooting Guide

2025 Edition

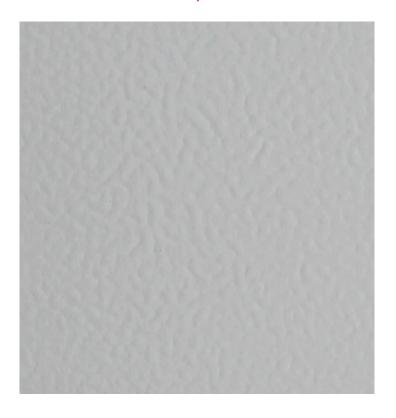
Wrinkling

A wrinkled texture on the surface of the product as it cures

- Applied WFT is higher than recommended or coated structure exposed to too high air flow
 - This leads to a 'skinning' effect, where the top layer dries before the material underneath has a chance to dry

- Nothing required from a fire-safety perspective no detrimental effect on fire performance
- If superior aesthetics are required: sand to smooth surface
- If possible, regulate airflow to optimise drying characteristics

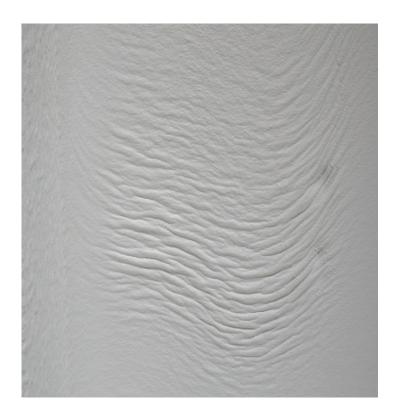
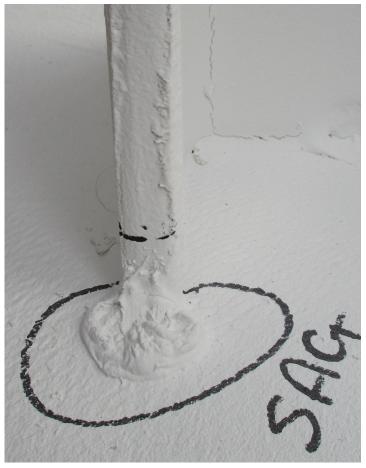
Slumping / sagging

- Product appears to 'sag' or 'slump' down
- Often, beads of paint pool and run down the surface

- Applied WFT much higher than recommended
- The product was thinned prior to use
- Applicator stood too close to the structure during application

- Nothing required from a fire-safety perspective no detrimental effect on fire performance
- If superior aesthetics are required: sand to smooth surface

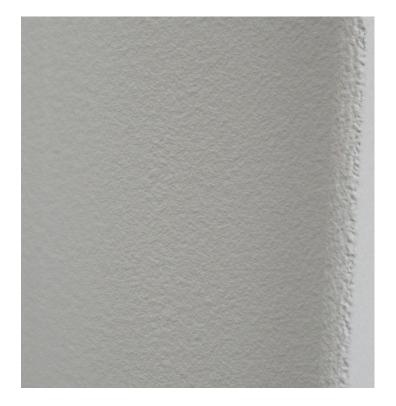
Dry spray

Poor atomization of intumescent material

- Applicator stood too far from structure during application
- · Application temperature too high
- Pump Pressure too high

- Nothing required from a fire-safety perspective no detrimental effect on fire performance
- Ensure pump pressures are within recommendations by manufacturer/in Hilti application guide
- Ensure you are at a correct spraying distance from the surface, and within product spray parameters
- If superior aesthetics are required: sand to smooth surface

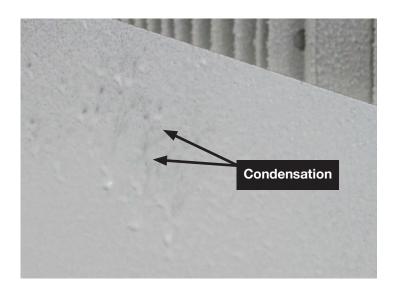
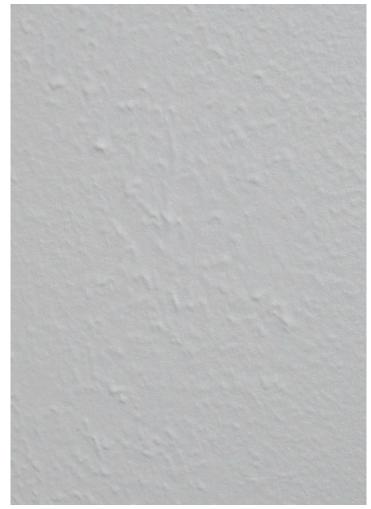
Poor hangability

You are getting lower than expected wet film thicknesses

- · Condensation / moisture on the steel surface
- Thinned product used
- · Residual water in the spray pump

- Nothing required from a fire-safety perspective no detrimental effect on fire performance
- · Let the intumescent coating dry completely
- If superior aesthetics are required: sand smooth

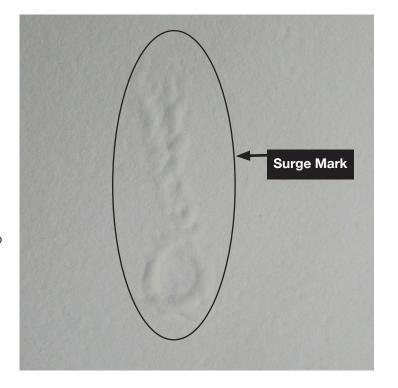
Surges

• Intumescent material that sprays out from pump in a stream vs. an atomized spray fan

- · Cavitation of the pump
- · Short tip blockage by foreign matter

- Cavitation: ensure sufficient level of intumescent in the pump feed
- No repairs required from a fire-safety perspective no detrimental effect on fire performance
- If superior aesthetics are required: sand to smooth surface
- Ensure that all connections of the pump are tight, and there is no air entering the pump
- Ensure that there is no dry or cured material inside the pump that can create an uneven flow

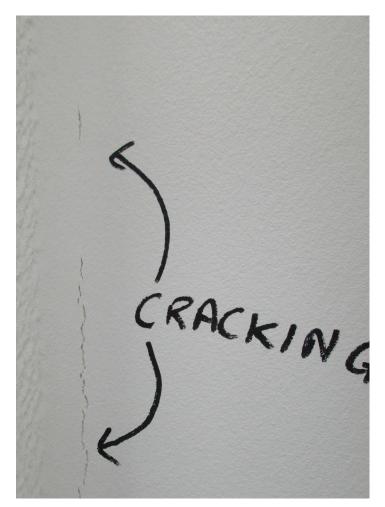
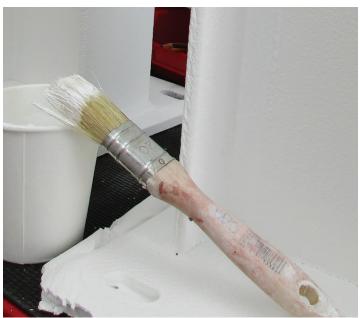
Cracks

Physical cracks running through surface of material

• Higher than recommended WFT, high air flow, low humidity

- Application of a stripe coat can prevent crack formation if conditions exist that favor crack formation
- For hairline cracks No repairs required from a fire-safety perspective — no detrimental effect on fire performance
 - All other cracks/gaps must be filled
- If superior aesthetics are required, apply a brush coat of material on top of the crack

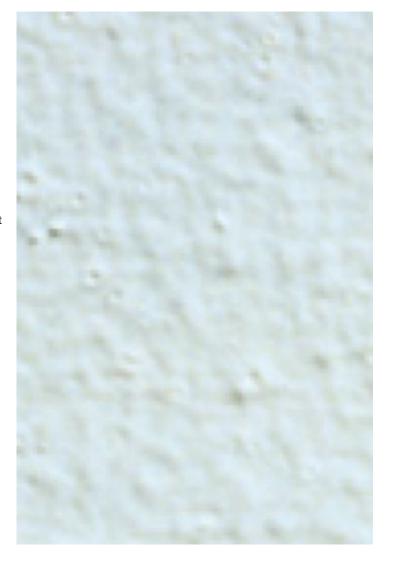
Pinholes

• Minor pinholes/craters in surface of product

- Poor atomization
- Air entrapment

- Check pump settings to ensure parameters are within product requirements
- Check tip for signs of wear, and when in doubt change it
- No repairs required from a fire-safety perspective no detrimental effect on fire performance
- If superior aesthetics are required: sand to smooth surface

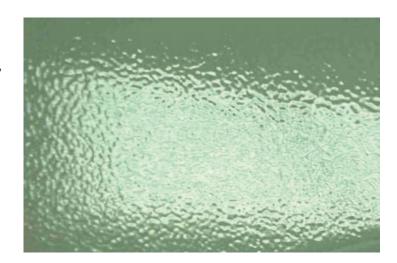
Orange Peel

· Rough textured appearance, similar to the peel of an orange, on the surface of the product

- Normal appearance for high build coatings
- High WFT have a propensity to orange peel
- High gloss top coat exacerbates the appearance

- No repairs required from a fire-safety perspective no detrimental effect on fire performance
- If superior aesthetics are required: sand to smooth surface

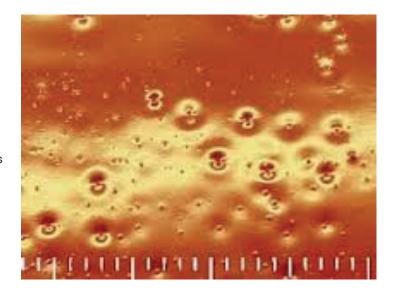
Cratering (top coats only)

Pock-marked top coat

- · Defect in the top coat caused by foreign matter
- Frequently observed with polyurethane and silicone top coats
- NOT a problem of the intumescent

- Ensure that top coat is properly mixed. When in doubt, filter the top coat
- Contact your topcoat manufacturer for continued issues
- No repairs required from a fire-safety perspective no detrimental effect on fire performance
- If superior aesthetics are required: smooth top coat and re-apply a thin layer

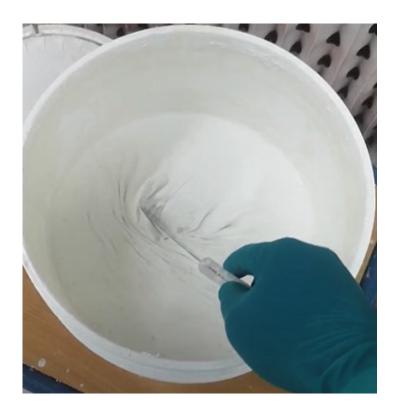
Skin formation in the pail

Extensive time or environmental factors (high air ventilation, high temperature and/or low humidity) are leading to the paint to dry (skin) at the surface of the pail.

- Remove the skin that has been formed by pulling it with an inert hard object (spatula, pallet knife, etc.)
- Once the complete skin has been removed from the pail, the wet paint remaining is ready to be used.

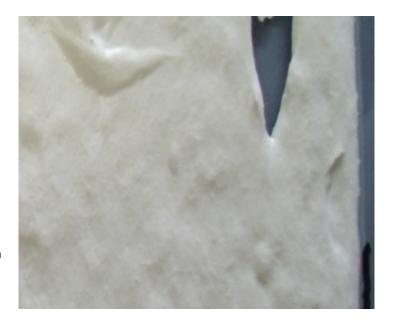
Product not adhering to the substrate

The spray product does not adhere to the substrate — slides off during the initial spraying/drying process

- The primer may not be compatible, or the product was applied outside of the specified recoat window (of its primer)
- · Contamination of substrate (oil, grease, ...)
- If a brand new pump is being used for the first time, the packing oils in the pump have not been fully cleaned out with solvent followed by throughly flushing out the pump/lines with water

- The Fire Finish product MUST be removed completely from the steel member
- · Check primer compatibility
 - Remove incompatible primer
 - Re-blast steel and apply approved primer
- Remove contamination
 - · De-grease, water jet, ...
 - Re-apply Fire Finish as per UL requirements

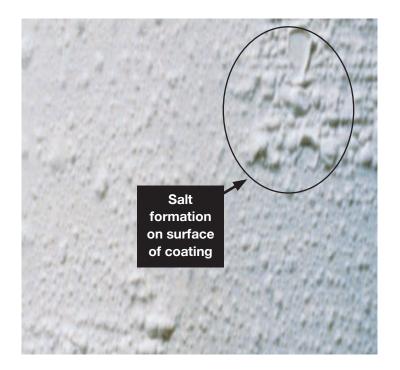
Efflorescence

Looks like there is 'salt formation' on the surface of the material

Exposure to water or use in exterior environments where an approved top coat was not applied

- The Fire Finish product MUST be removed completely from the steel member and reapplied
 - No way to repair the material fire performance has been compromised

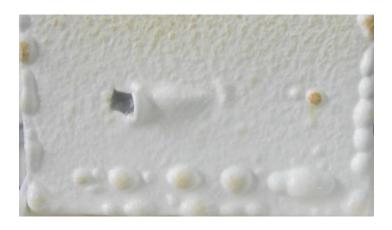
Blistering

• Surface of the material seems to have 'blisters' on it

- Exposure to pooling / standing / running water
- Possible surface contamination

- The Fire Finish product MUST be removed completely from the steel member and reapplied
 - No way to repair the material fire performance has been compromised

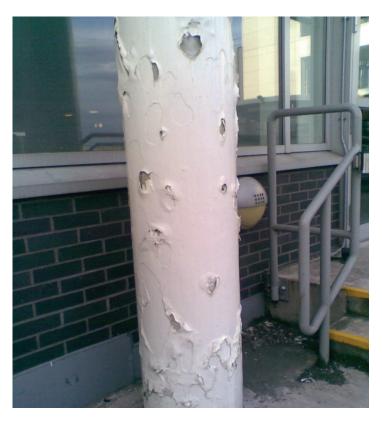
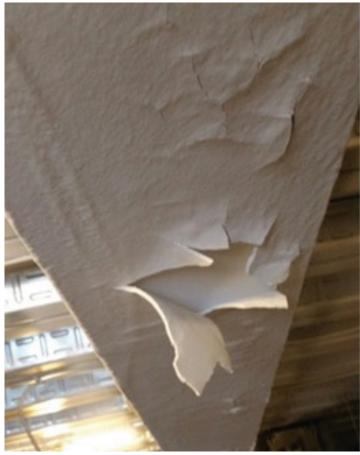
Delamination

· Product delaminates off the steel structure after it is dry

- If the product has not cured and does not adhere or if the product is cured and delaminates, product has been applied over incompatible primer
- Contamination of substrate or product
- · Moisture ingression over time

- The Fire Finish product and base Primer MUST be removed completely from the column and reapplied
 - No way to repair the material fire performance has been compromised
- Re-apply after blast cleaning and priming the steel with an approved primer

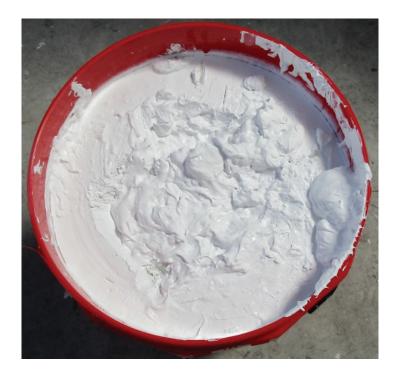
Frost damage of the wet coating

Coagulated product that can not be stirred up

The product has been frozen and subsequently thawed

- Some pails/pallets will carry freeze indicator, please check if activate
- DO NOT USE: Dispose of complete bucket if freeze indicator activated or evidence the pail has been frozen
