TROUBLESHOOTING GUIDE

Fire Finish 120+ CFP-SP WB

2023 Edition

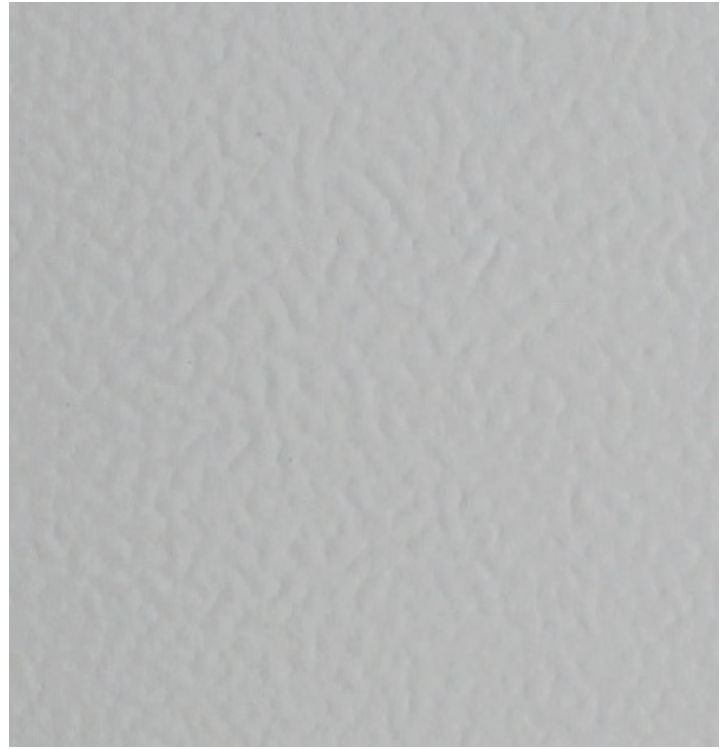
WRINKLING

- A wrinkled texture on the surface of the product as it cures

- Applied WFT is higher than recommended or coated structure exposed to too high air flow
 - This leads to a 'skinning' effect, where the top layer dries before the material underneath has a chance to dry

- Nothing required from a fire-safety perspective — no detrimental effect on fire performance
- If superior aesthetics are required: sand to smooth surface
- If possible, regulate airflow to optimise drying characteristics

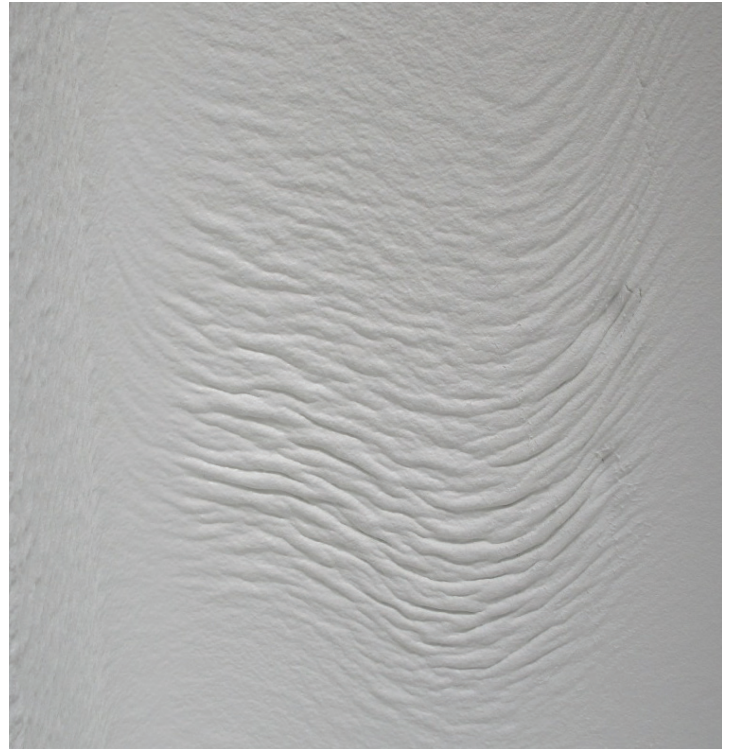
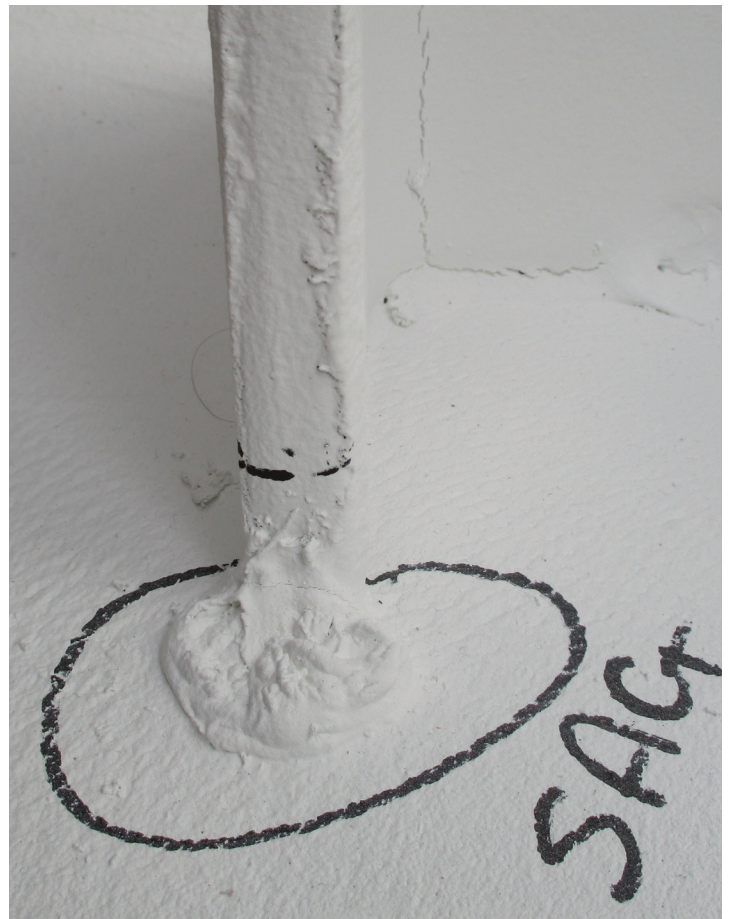
SLUMPING / SAGGING

- Product appears to 'sag' or 'slump' down
- Often, beads of paint pool and run down the surface

- Applied WFT much higher than recommended
- The product was thinned prior to use
- Applicator stood too close to the structure during application

- Nothing required from a fire-safety perspective — no detrimental effect on fire performance
- If superior aesthetics are required: sand to smooth surface

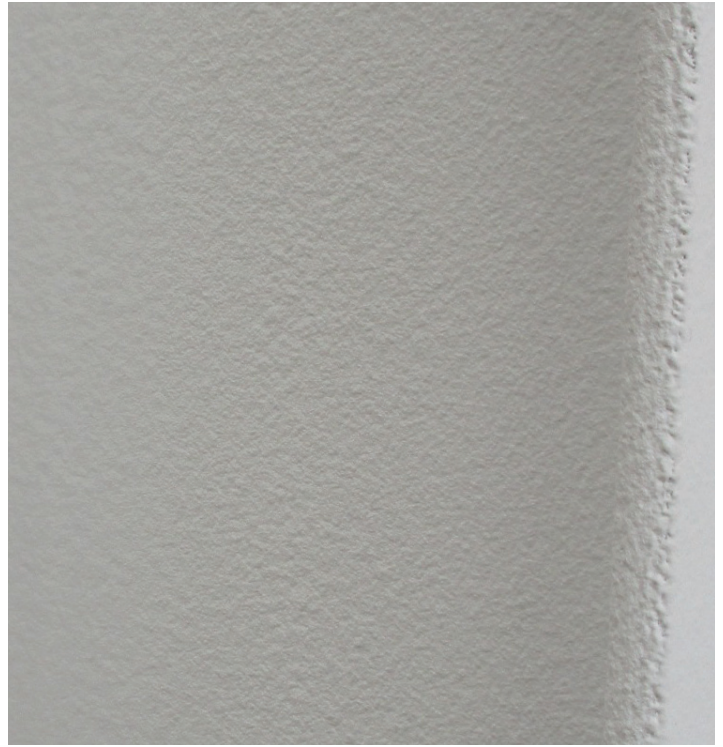
DRY SPRAY

- Poor atomization of intumescent material

- Applicator stood too far from structure during application
- Application temperature too high
- Pump Pressure too high

- Nothing required from a fire-safety perspective — no detrimental effect on fire performance
- Ensure pump pressures are within recommendations by manufacturer/in Hilti application guide
- Ensure you are at a correct spraying distance from the surface, and within product spray parameters
- If superior aesthetics are required: sand to smooth surface

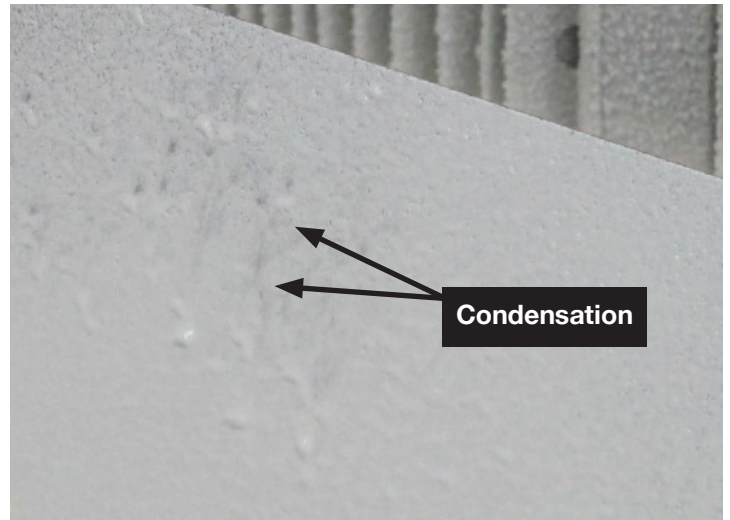
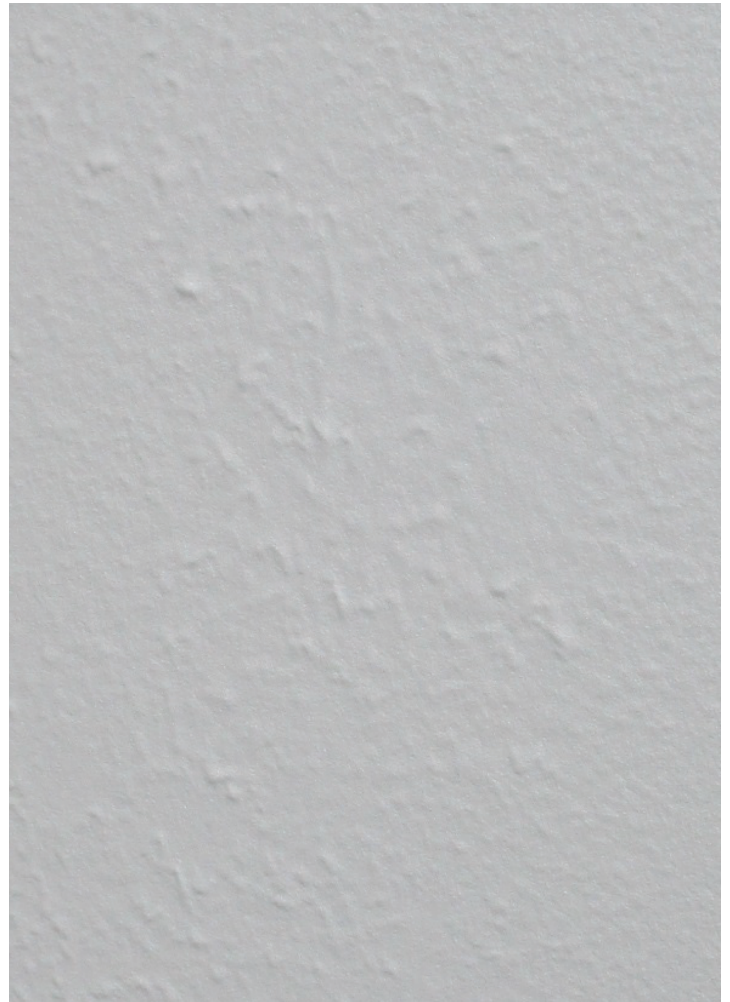
POOR HANGABILITY

- You are getting lower than expected wet film thicknesses

- Condensation / moisture on the steel surface
- Thinned product used
- Residual water in the spray pump

- Nothing required from a fire-safety perspective — no detrimental effect on fire performance
- Let the intumescent coating dry completely
- If superior aesthetics are required: sand smooth

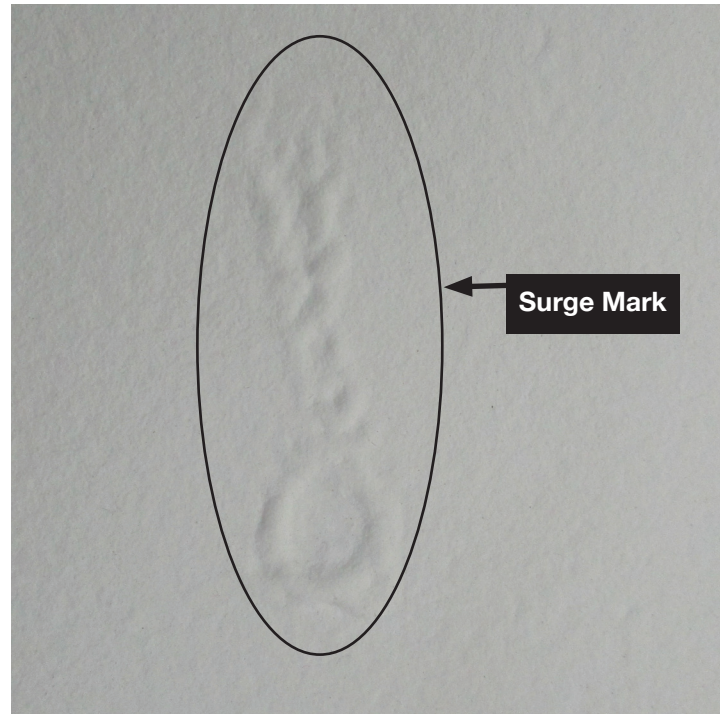
SURGES

- Intumescent material that sprays out from pump in a stream vs. an atomized spray fan

- Cavitation of the pump
- Short tip blockage by foreign matter

- **Cavitation:** ensure sufficient level of intumescent in the pump feed
- No repairs required from a fire-safety perspective — no detrimental effect on fire performance
- If superior aesthetics are required: sand to smooth surface
- Ensure that all connections of the pump are tight, and there is no air entering the pump
- Ensure that there is no dry or cured material inside the pump that can create an uneven flow

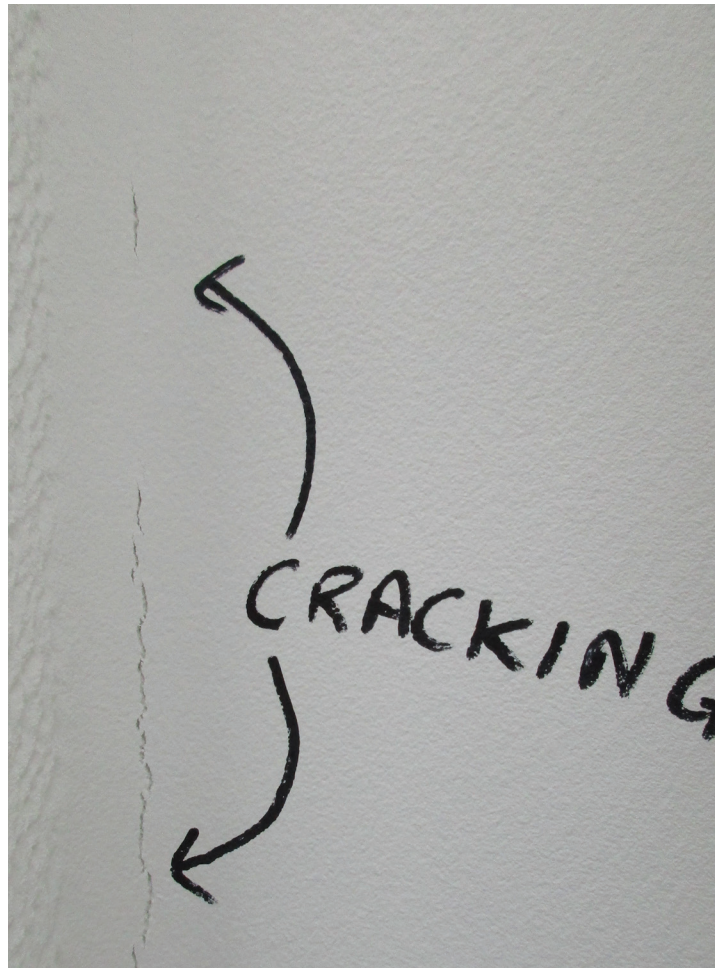
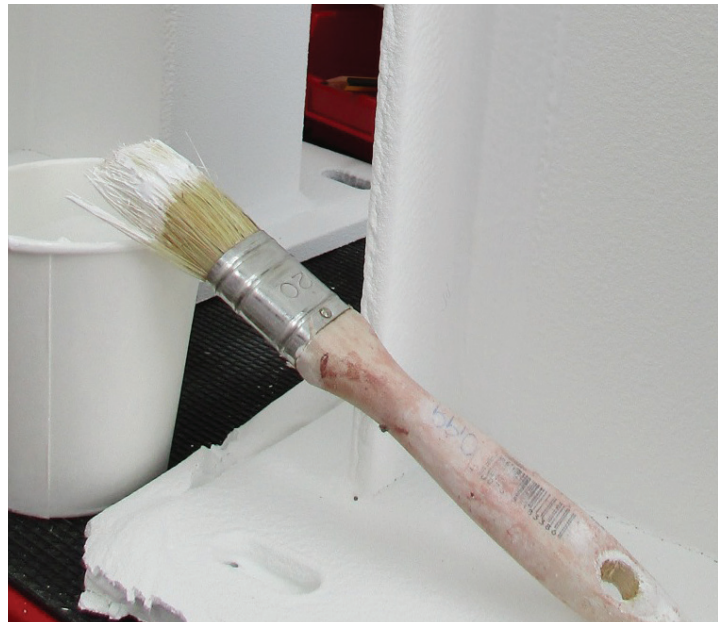
CRACKS

- Physical cracks running through surface of material

- Higher than recommended WFT, high air flow, low humidity

- Application of a stripe coat can prevent crack formation if conditions exist that favor crack formation
- For hairline cracks — No repairs required from a fire-safety perspective — no detrimental effect on fire performance
 - All other cracks/gaps must be filled
- If superior aesthetics are required, apply a brush coat of material on top of the crack

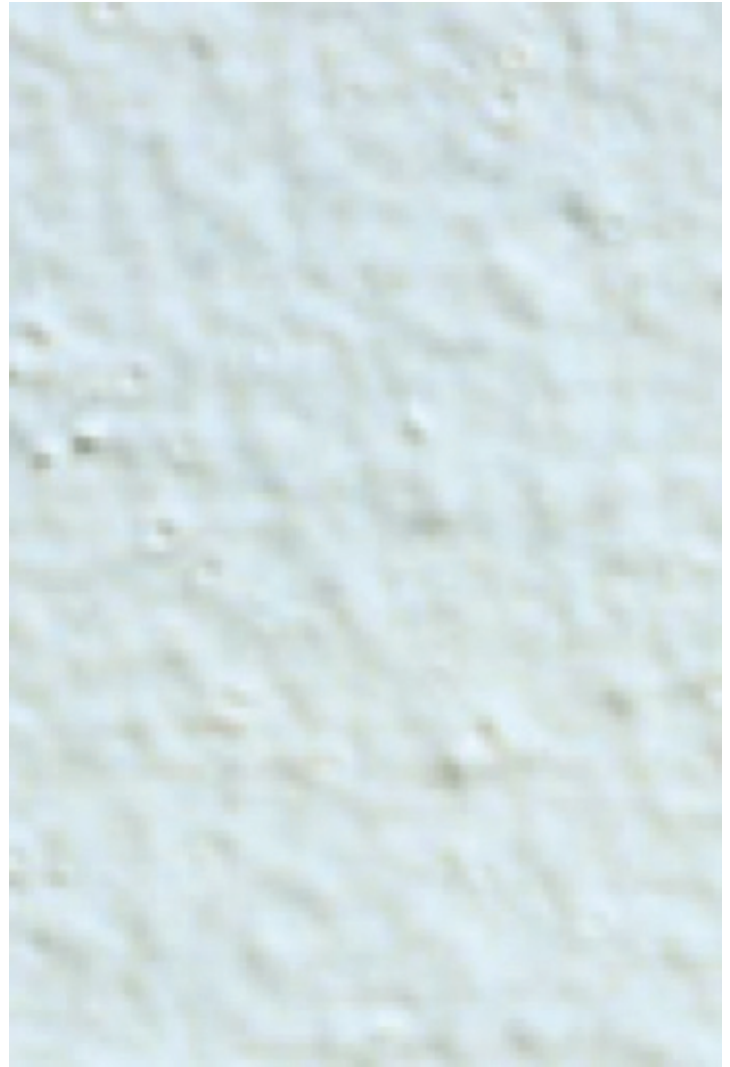
PINHOLES

- Minor pinholes/craters in surface of product

- Poor atomization
- Air entrapment

- Check pump settings to ensure parameters are within product requirements
- Check tip for signs of wear, and when in doubt — change it
- No repairs required from a fire-safety perspective — no detrimental effect on fire performance
- If superior aesthetics are required: sand to smooth surface

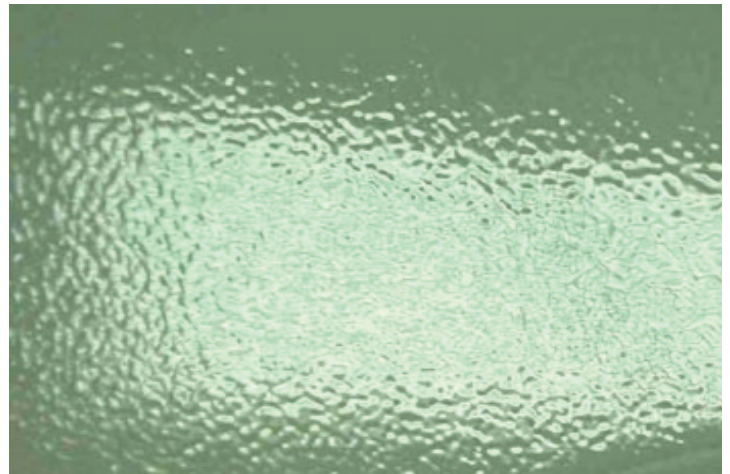
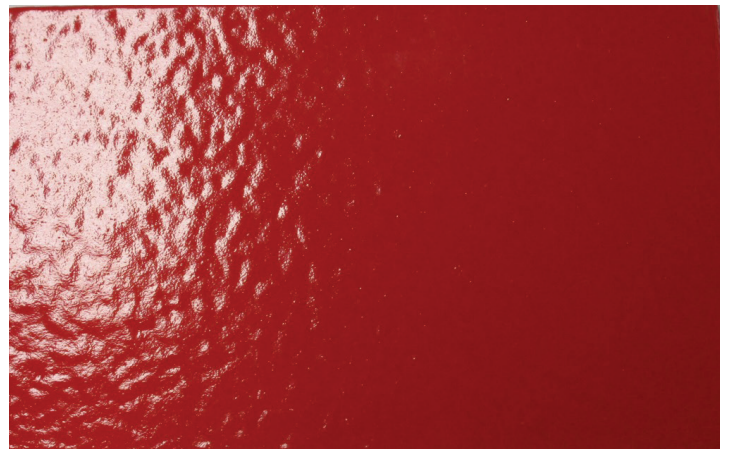
ORANGE PEEL

- Rough textured appearance, similar to the peel of an orange, on the surface of the product

- Normal appearance for high build coatings
- High WFT have a propensity to orange peel
- High gloss top coat exacerbates the appearance

- No repairs required from a fire-safety perspective — no detrimental effect on fire performance
- If superior aesthetics are required: sand to smooth surface

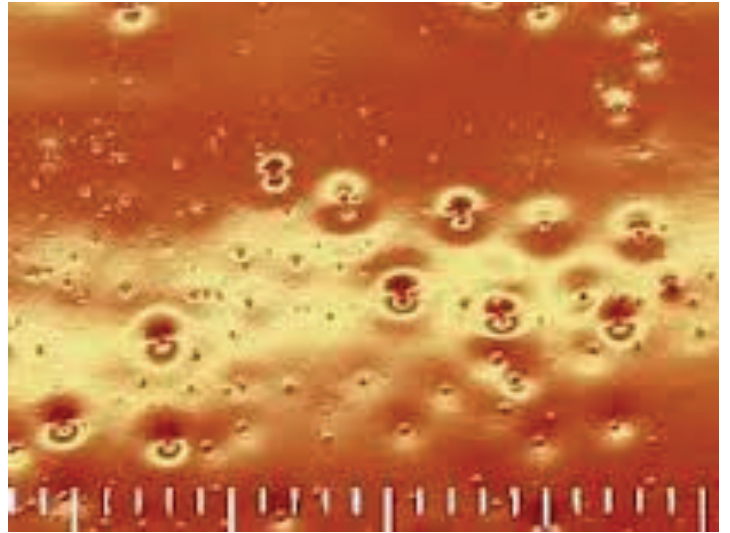
CRATERING (TOP COATS ONLY)

- Pock-marked top coat

- Defect in the top coat caused by foreign matter
- Frequently observed with polyurethane and silicone top coats
- NOT a problem of the intumescent

- Ensure that top coat is properly mixed. When in doubt, filter the top coat
- Contact your topcoat manufacturer for continued issues
- No repairs required from a fire-safety perspective — no detrimental effect on fire performance
- If superior aesthetics are required: smooth top coat and re-apply a thin layer

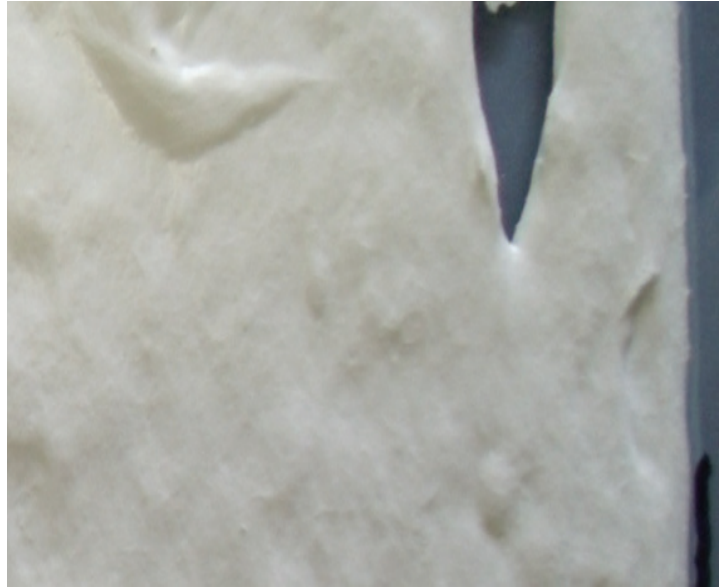
PRODUCT NOT ADHERING TO THE SUBSTRATE

- The spray product does not adhere to the substrate — slides off during the initial spraying/drying process

- The primer may not be compatible, or the product was applied outside of the specified recoat window (of its primer)
- Contamination of substrate (oil, grease, ...)
- If a brand new pump is being used for the first time, the packing oils in the pump have not been fully cleaned out with solvent followed by thoroughly flushing out the pump/lines with water

- The Fire Finish product **MUST** be removed completely from the steel member
- Check primer compatibility
 - Remove incompatible primer
 - Re-blast steel and apply approved primer
- Remove contamination
 - De-grease, water jet, ...
 - Re-apply Fire Finish as per UL requirements

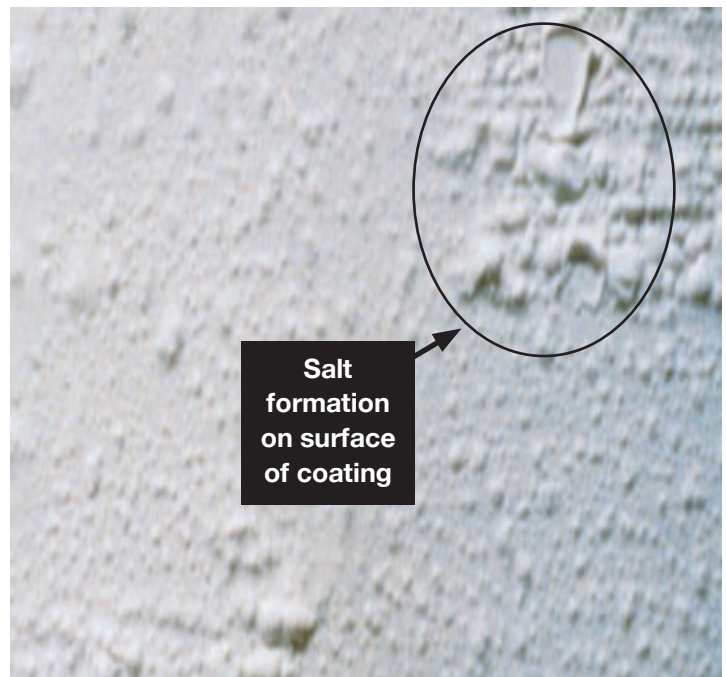
EFFLORESCENCE

- Looks like there is 'salt formation' on the surface of the material

- Exposure to water or use in exterior environments where an approved top coat was not applied

- The Fire Finish product MUST be removed completely from the steel member and reapplied
 - No way to repair the material — fire performance has been compromised

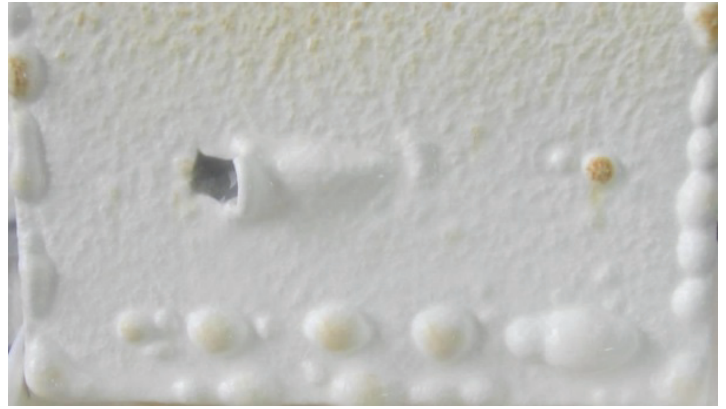
BLISTERING

- Surface of the material seems to have ‘blisters’ on it

- Exposure to pooling / standing / running water
- Possible surface contamination

- The Fire Finish product MUST be removed completely from the steel member and reapplied
 - No way to repair the material — fire performance has been compromised

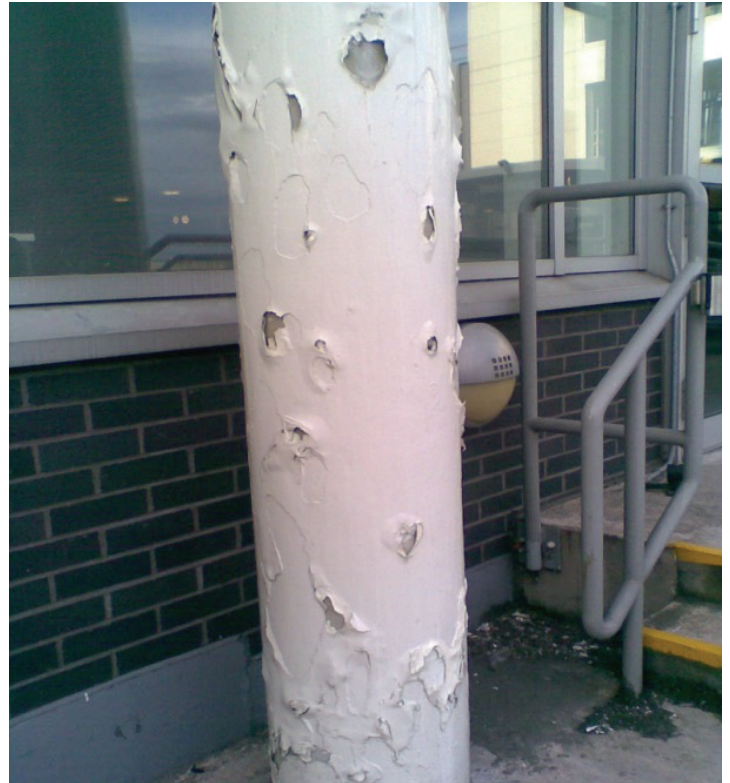
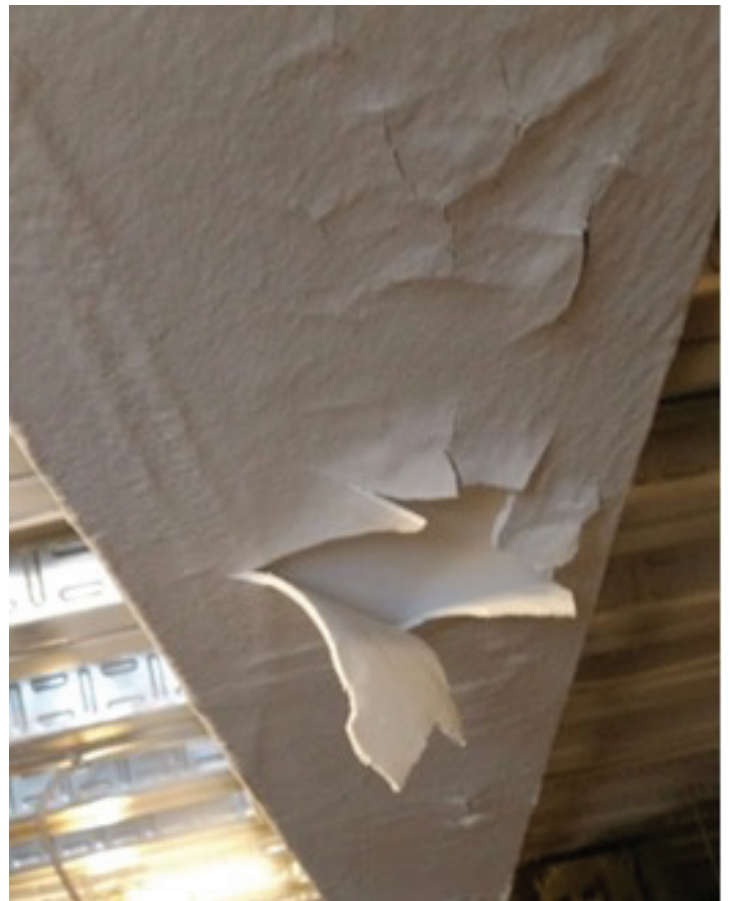
DELAMINATION

- Product delaminates off the steel structure after it is dry

- If the product has not cured and does not adhere or if the product is cured and delaminates, product has been applied over incompatible primer
- Contamination of substrate or product
- Moisture ingress over time

- The Fire Finish product and base Primer MUST be removed completely from the column and reapplied
 - No way to repair the material — fire performance has been compromised
- Re-apply after blast cleaning and priming the steel with an approved primer

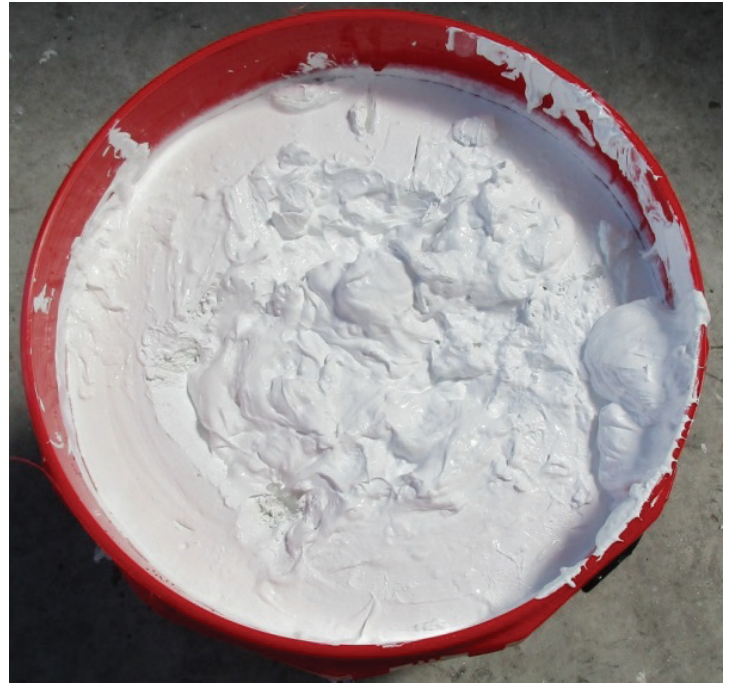
FROST DAMAGE OF THE WET COATING

- Coagulated product that can not be stirred up

- The product has been frozen and subsequently thawed

- DO NOT USE: Dispose of complete bucket if freeze indicator is activated
