TROUBLESHOOTING GUIDE

Fire Finish 120+ CFP-SP WB

2024 Edition

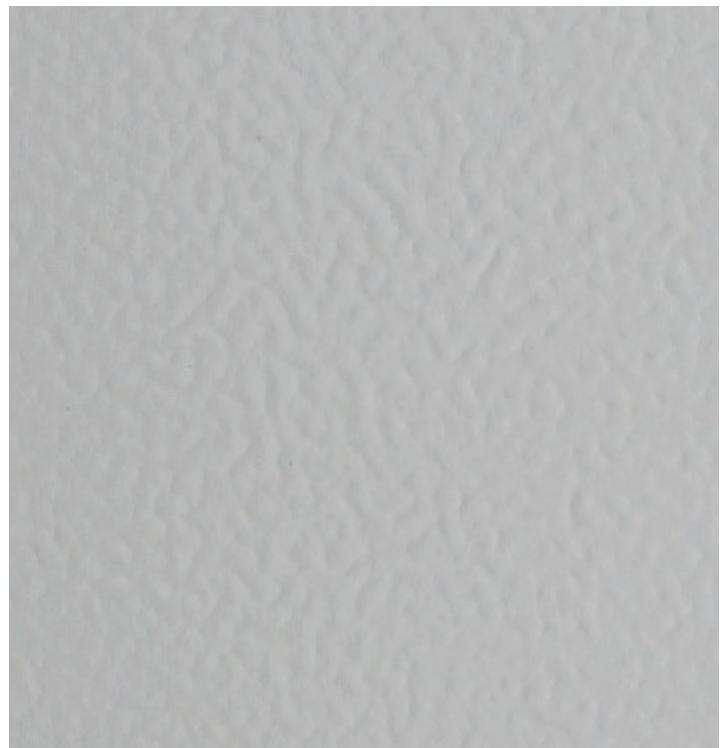
WRINKLING

- A wrinkled texture on the surface of the product as it cures

- Applied WFT is higher than recommended.
- Coated structure exposed to too high air flow and/or high temperature
 - This leads to a 'skinning' effect, where the top layer dries before the material underneath has a chance to dry

- Nothing required from a fire-safety perspective — no detrimental effect on fire performance
- If superior aesthetics are required: sand to smooth surface
- If possible, regulate airflow to optimise drying characteristics

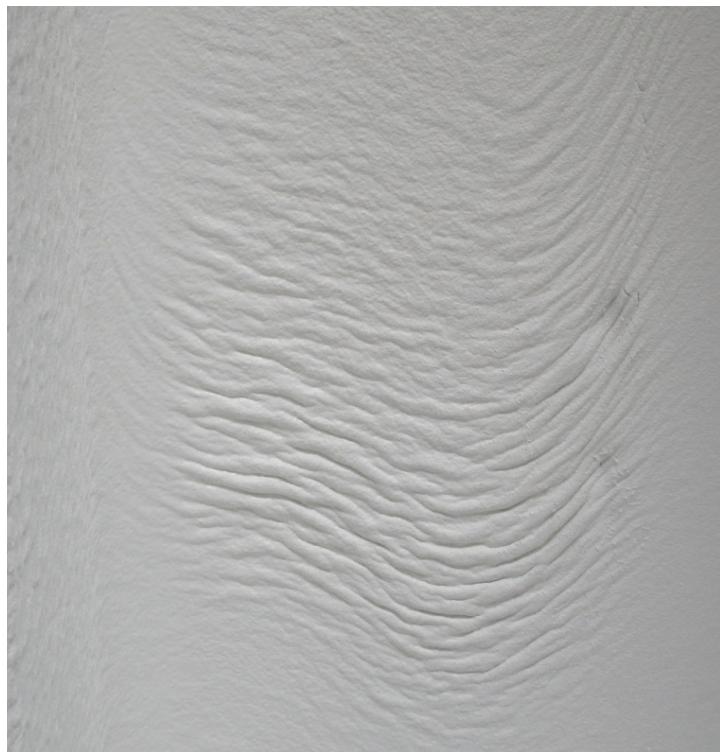
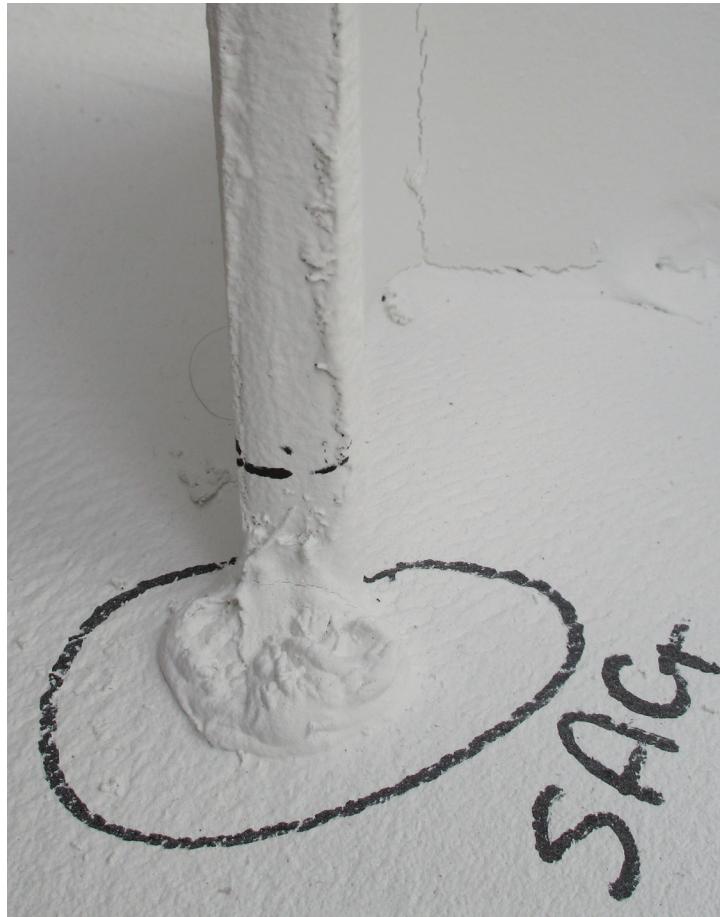
POOR HANGABILITY

- Product appears to 'sag' or 'slump' down
- Often, beads of paint pool and run down the surface

- Applied WFT much higher than recommended
- The product was thinned prior to use
- Applicator stood too close to the structure during application

- Nothing required from a fire-safety perspective — no detrimental effect on fire performance
- If superior aesthetics are required: sand to smooth surface

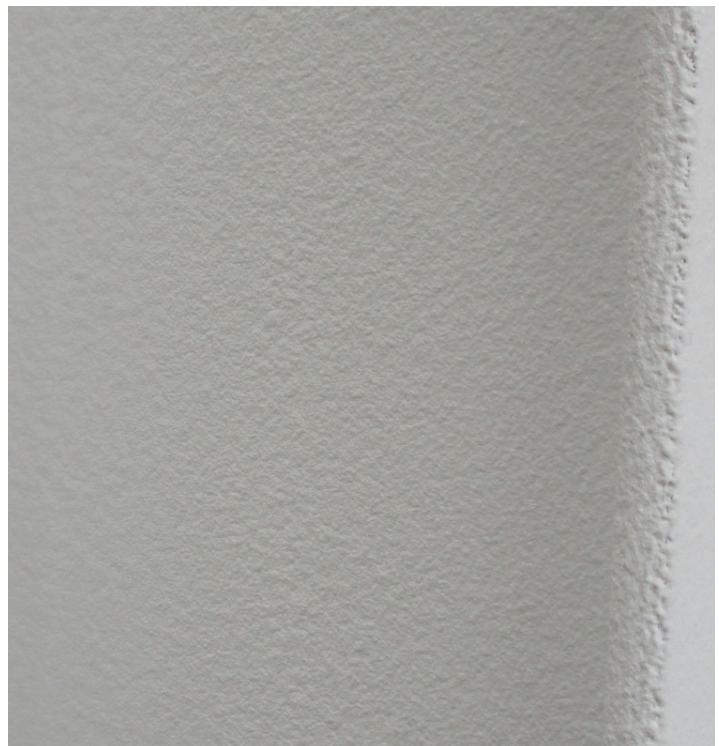
DRY SPRAY

- Poor atomization of intumescent material

- Applicator stood too far from structure during application
- Application temperature too high
- Pump Pressure too high

- Nothing required from a fire-safety perspective — no detrimental effect on fire performance
- Ensure pump pressures are within recommendations by manufacturer/in Hilti application guide
- Ensure you are at a correct spraying distance from the surface, and within product spray parameters
- If superior aesthetics are required: sand to smooth surface

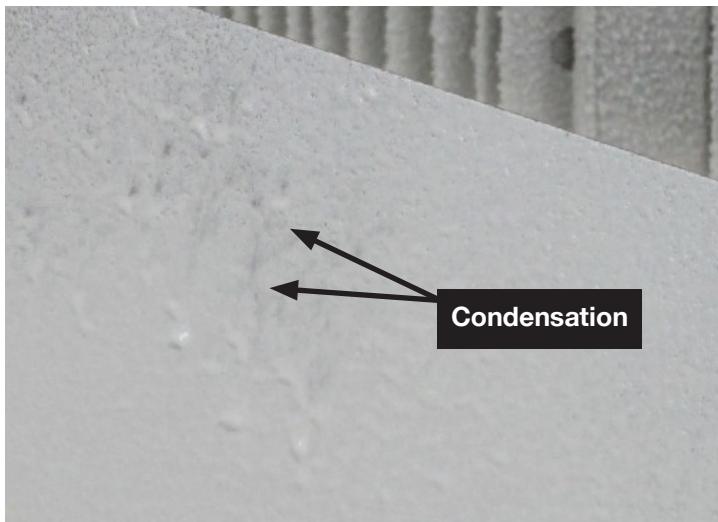
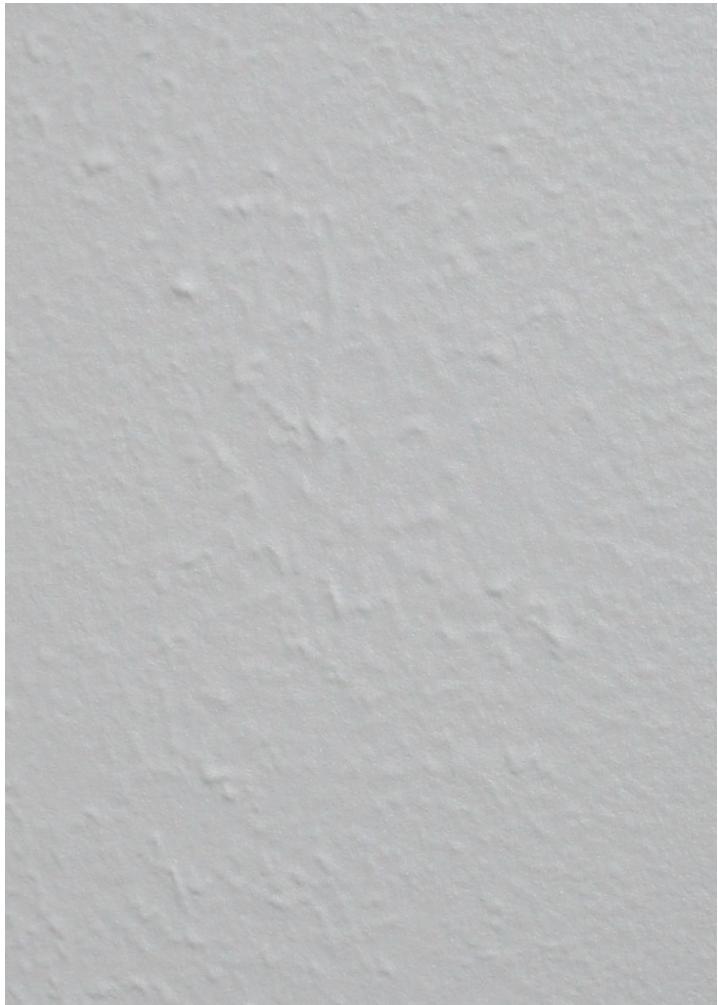
SLUMPING OR SLIDING

- Wet film thicknesses lower than expected.
- The coating slides down the surface of previous coat

- Condensation / moisture on the steel surface
- Surface contaminants (oil, water or other foreign material)
- Thinned product used
- Residual water in the spray pump

- If the slumped surface achieved the required DFT, nothing required from a fire-safety perspective — no detrimental effect on fire performance
- If the slumped surface did not achieve the required DFT, a new coat must be applied in that area.
- Let the intumescent coating dry completely
- If superior aesthetics are required: sand smooth

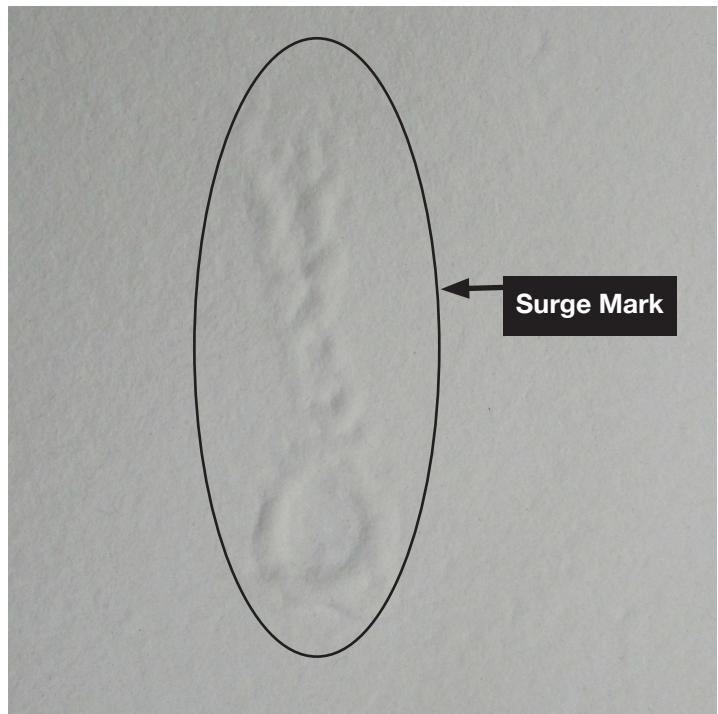
SURGES

- Intumescent material that sprays out from pump in a stream vs. an atomized spray fan

- Cavitation of the pump
- Short tip blockage by foreign matter

- **Cavitation:** ensure sufficient level of intumescent in the pump feed
- No repairs required from a fire-safety perspective — no detrimental effect on fire performance
- If superior aesthetics are required: sand to smooth surface
- Ensure that all connections of the pump are tight, and there is no air entering the pump
- Ensure that there is no dry or cured material inside the pump that can create an uneven flow

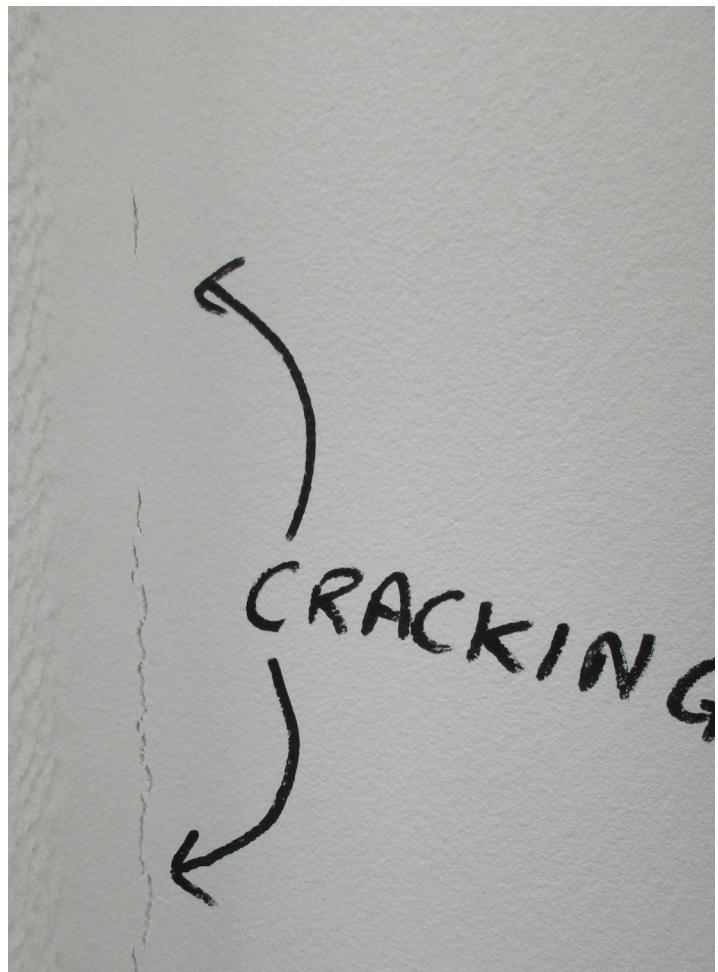
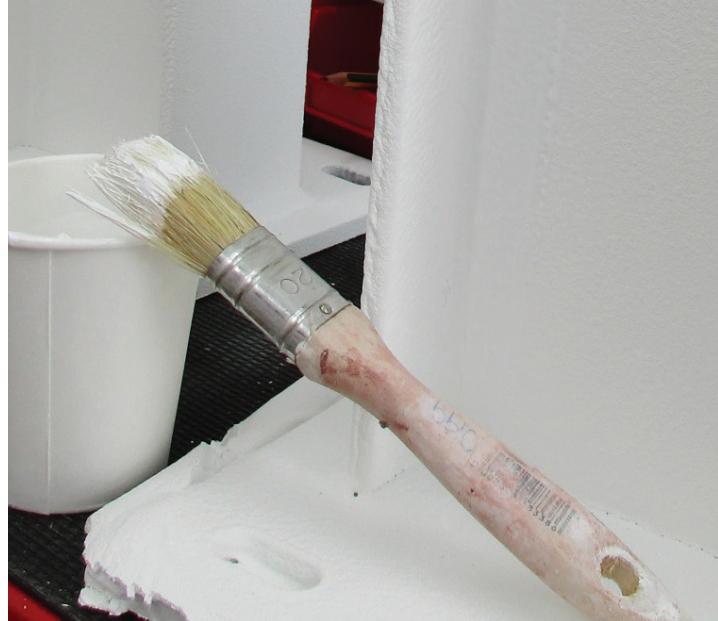
CRACKS

- Physical cracks running through surface of material

- Higher than recommended WFT, low air flow, high humidity and cold temperatures.

- Application of a stripe coat can prevent crack formation if conditions exist that favor crack formation
- For hairline cracks — No repairs required from a fire-safety perspective — no detrimental effect on fire performance
 - All other cracks/gaps must be filled
- If superior aesthetics are required, apply a brush coat of material on top of the crack

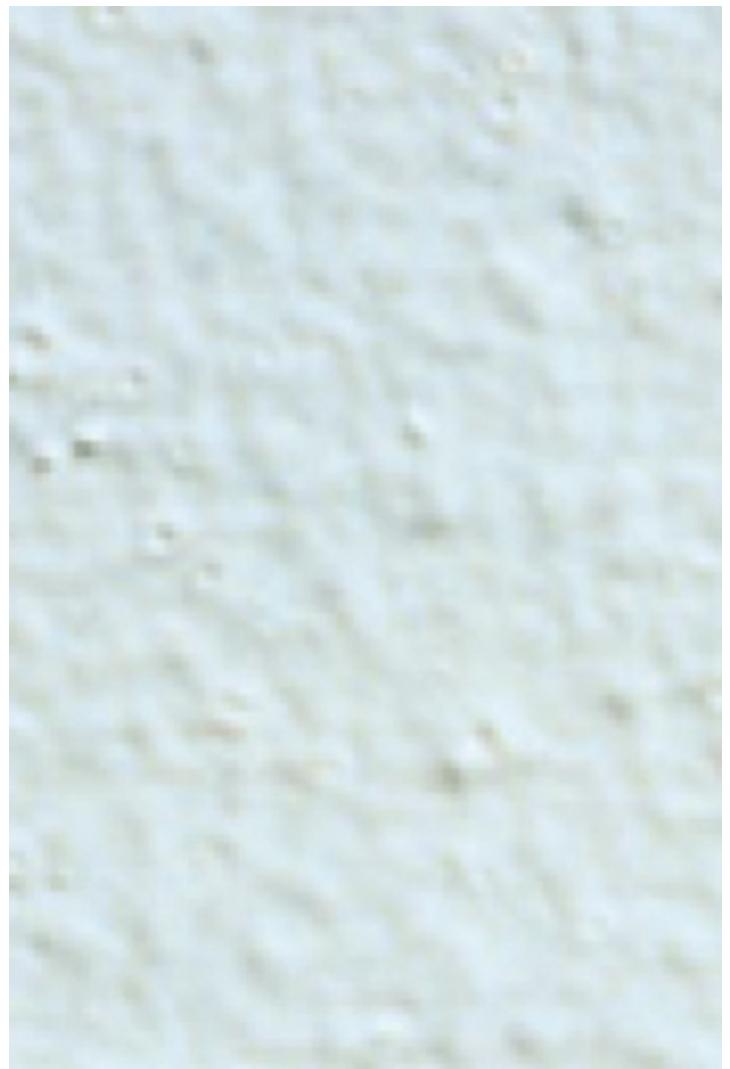
PINHOLES

- Minor pinholes/craters in surface of product

- Poor atomization
- Air entrapment

- Check pump settings to ensure parameters are within product requirements
- Check tip for signs of wear, and when in doubt — change it
- No repairs required from a fire-safety perspective — no detrimental effect on fire performance
- If superior aesthetics are required: sand to smooth surface

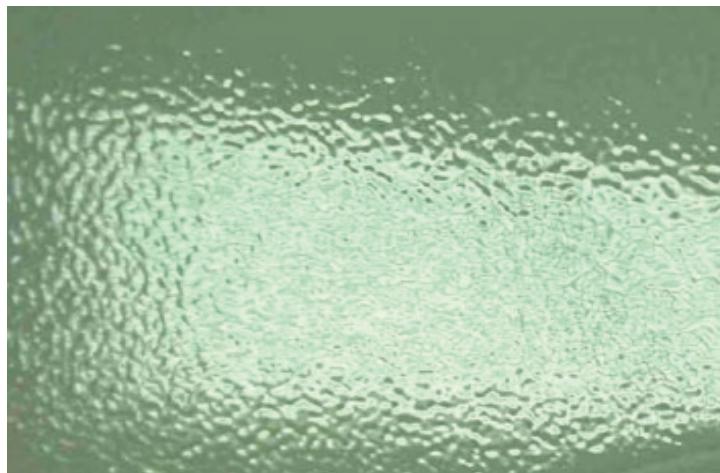
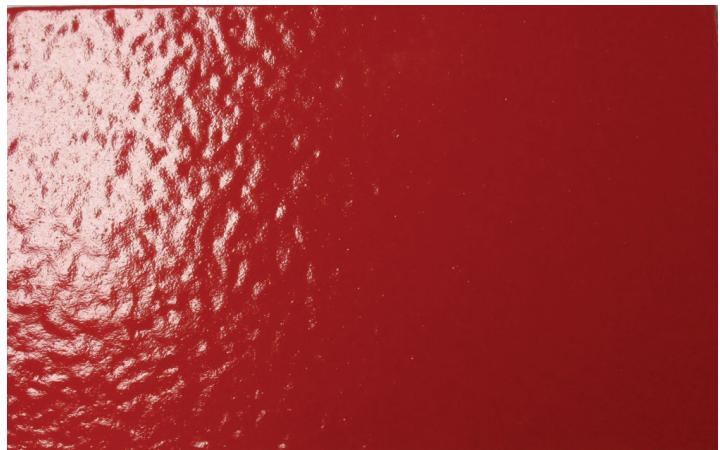
ORANGE PEEL

- Rough textured appearance, similar to the peel of an orange, on the surface of the product

- Normal appearance for high build coatings
- High WFT have a propensity to orange peel
- High gloss top coat exacerbates the appearance

- No repairs required from a fire-safety perspective — no detrimental effect on fire performance
- If superior aesthetics are required: sand to smooth surface

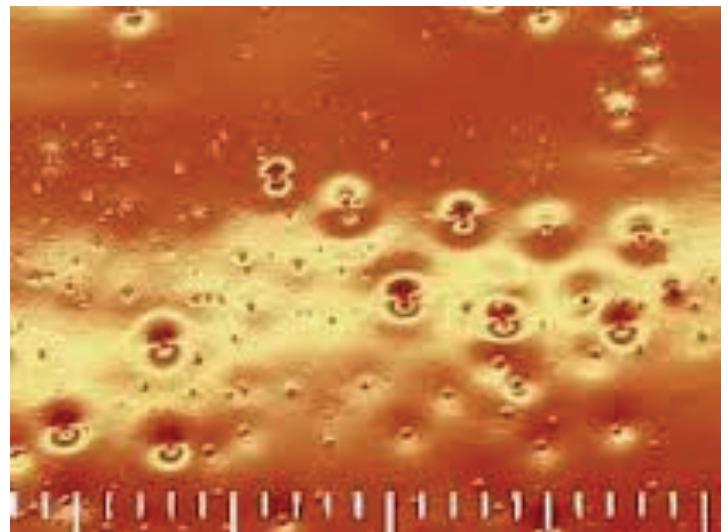
CRATERING (TOP COATS ONLY)

- Pock-marked top coat

- Defect in the top coat caused by foreign matter
- Frequently observed with polyurethane and silicone top coats
- NOT a problem of the intumescent

- Ensure that top coat is properly mixed. When in doubt, filter the top coat
- Contact your topcoat manufacturer for continued issues
- No repairs required from a fire-safety perspective — no detrimental effect on fire performance
- If superior aesthetics are required: smooth top coat and re-apply a thin layer

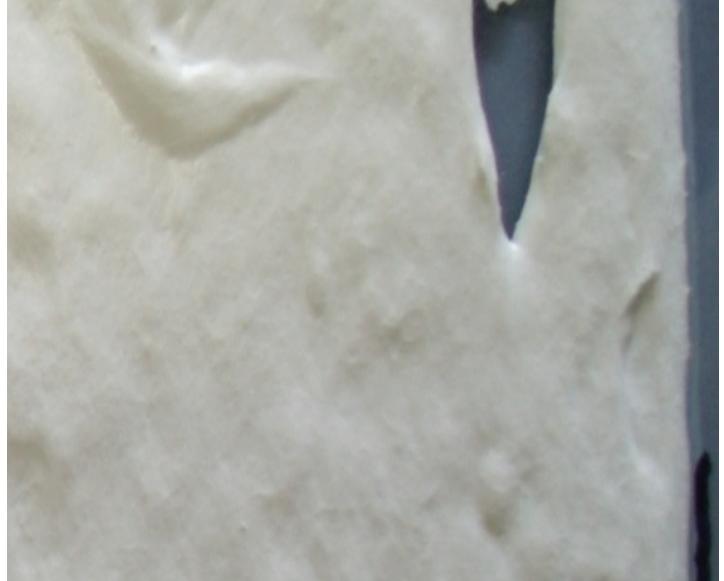
PRODUCT NOT ADHERING TO THE SUBSTRATE

- The spray product does not adhere to the substrate — slides off during the initial spraying/drying process

- The primer may not be compatible, or the product was applied outside of the specified recoat window (of its primer)
- Contamination of substrate (oil, grease, ...)
- If a brand new pump is being used for the first time, the packing oils in the pump have not been fully cleaned out with solvent followed by thoroughly flushing out the pump/lines with water

- The Fire Finish product MUST be removed completely from the steel member
- Check primer compatibility
 - Remove incompatible primer
 - Re-blast steel and apply approved primer
- Remove contamination
 - De-grease, water jet, ...
 - Re-apply Fire Finish as per UL requirements

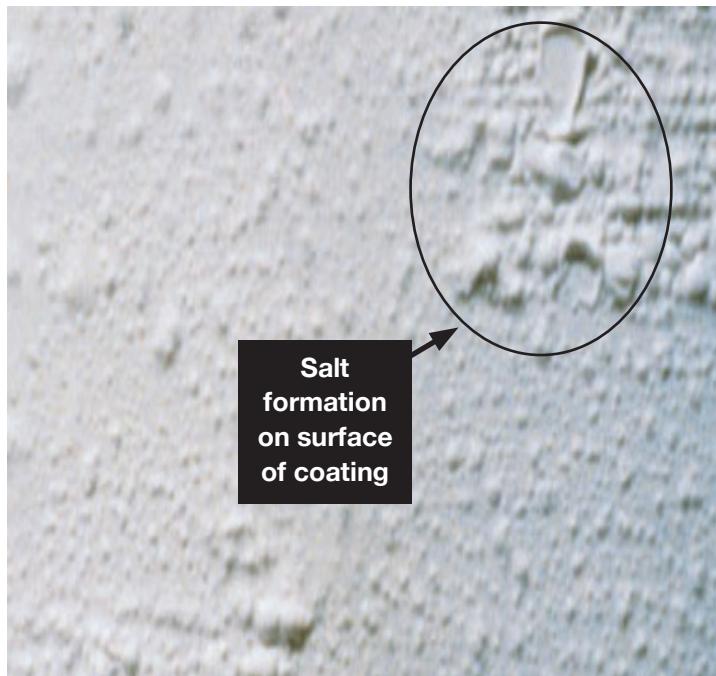
EFFLORESCENCE

- Looks like there is 'salt formation' on the surface of the material

- Exposure to water or use in exterior environments where an approved top coat was not applied

- The Fire Finish product MUST be removed completely from the steel member and reapplied
 - No way to repair the material — fire performance has been compromised

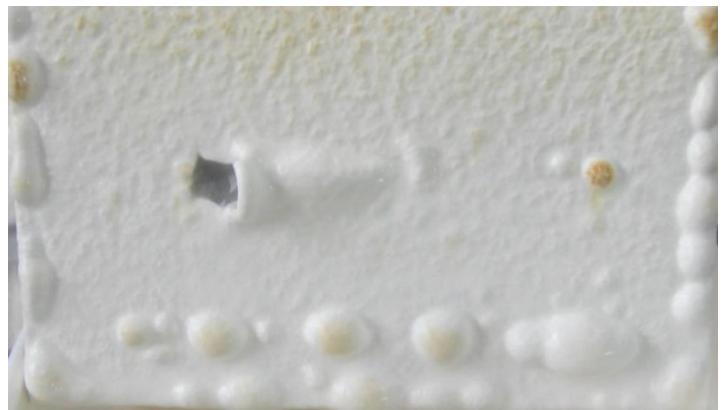
BLISTERING

- Surface of the material seems to have 'blisters' on it

- Exposure to pooling / standing / running water
- Possible surface contamination

- The Fire Finish product MUST be removed completely from the steel member and reapplied
 - No way to repair the material — fire performance has been compromised

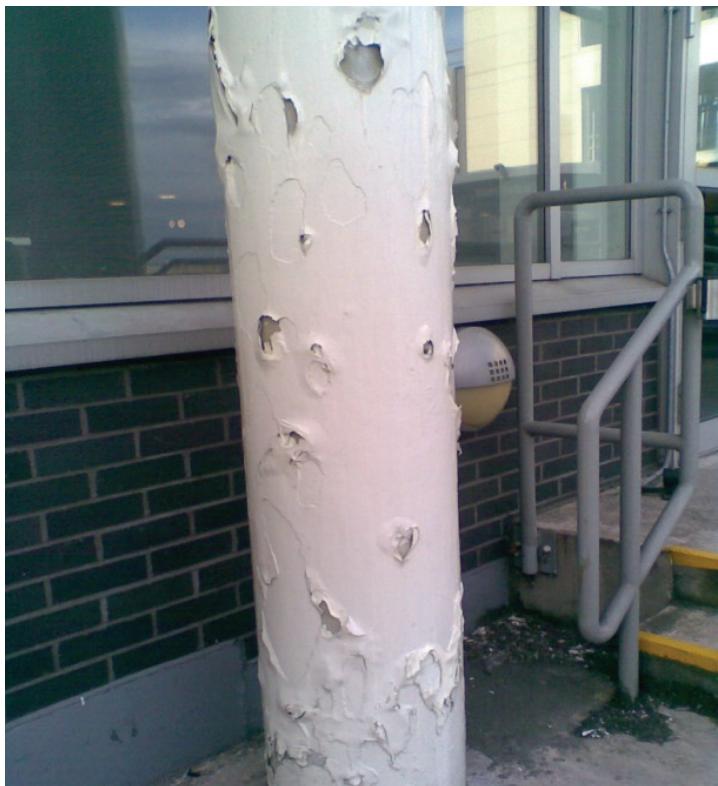
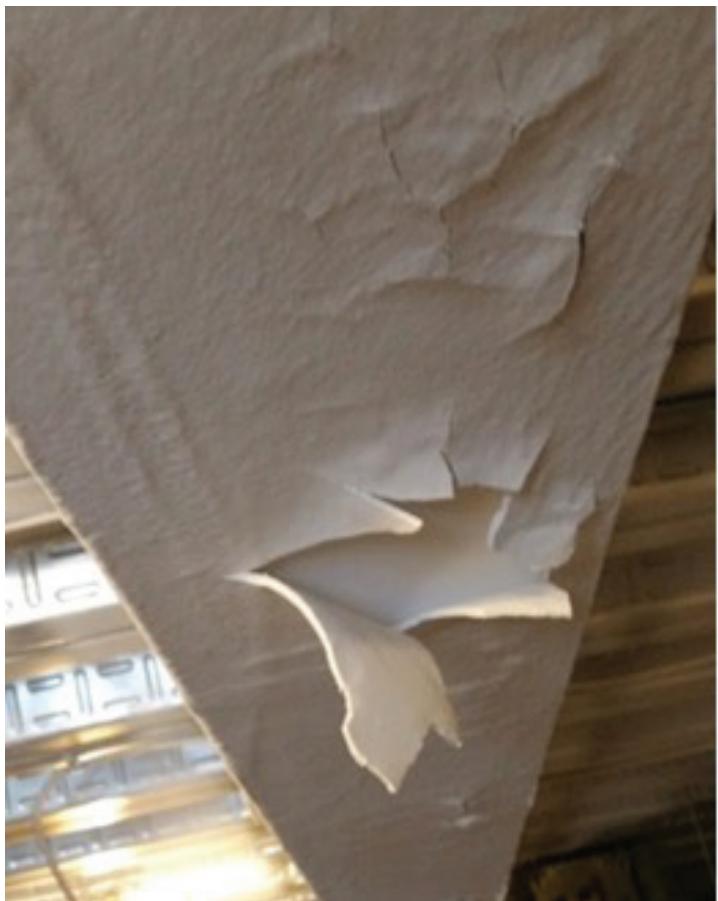
DELAMINATION

- Product delaminates off the steel structure after it is dry

- If the product has not cured and does not adhere or if the product is cured and delaminates, product has been applied over incompatible primer
- Contamination of substrate or product
- Moisture ingress over time

- The Fire Finish product and base Primer MUST be removed completely from the column and reapplied
 - No way to repair the material — fire performance has been compromised
- Re-apply after blast cleaning and priming the steel with an approved primer

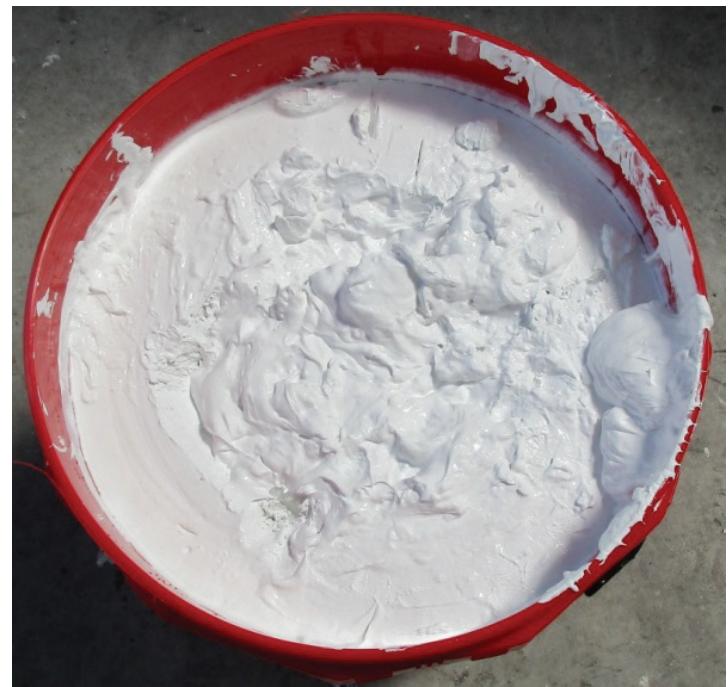
FROST DAMAGE OF THE WET COATING

- Coagulated product that can not be stirred up

- The product has been frozen and subsequently thawed

- DO NOT USE: Dispose of complete bucket if freeze indicator is activated
