Contents

Fire Finish CFP-SP WB

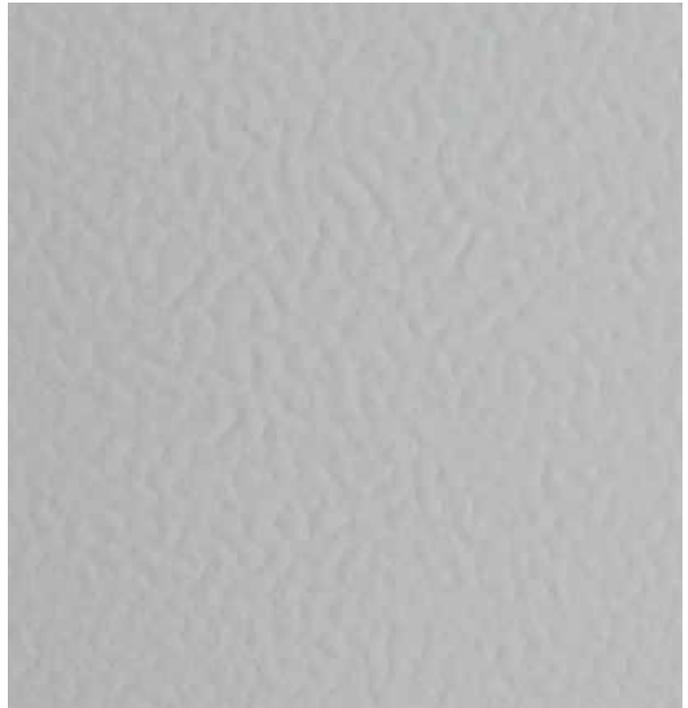
Wrinkling

- A wrinkled texture on the surface of the product as it cures

- Applied WFT is higher than recommended
 - This leads to a 'skinning' effect, where the top layer dries before the material underneath has a chance to dry

- Nothing required from a fire-safety perspective — no detrimental effect on fire performance
- If superior aesthetics are required: sand to smooth surface

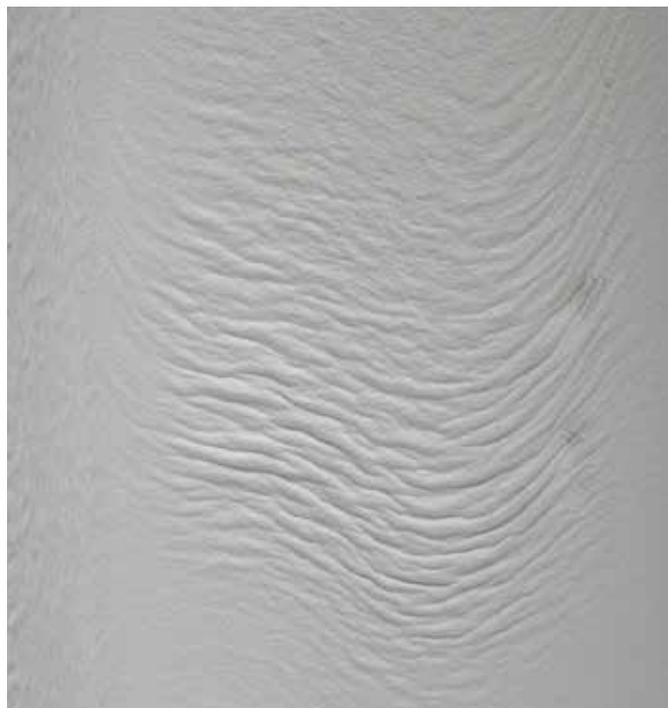
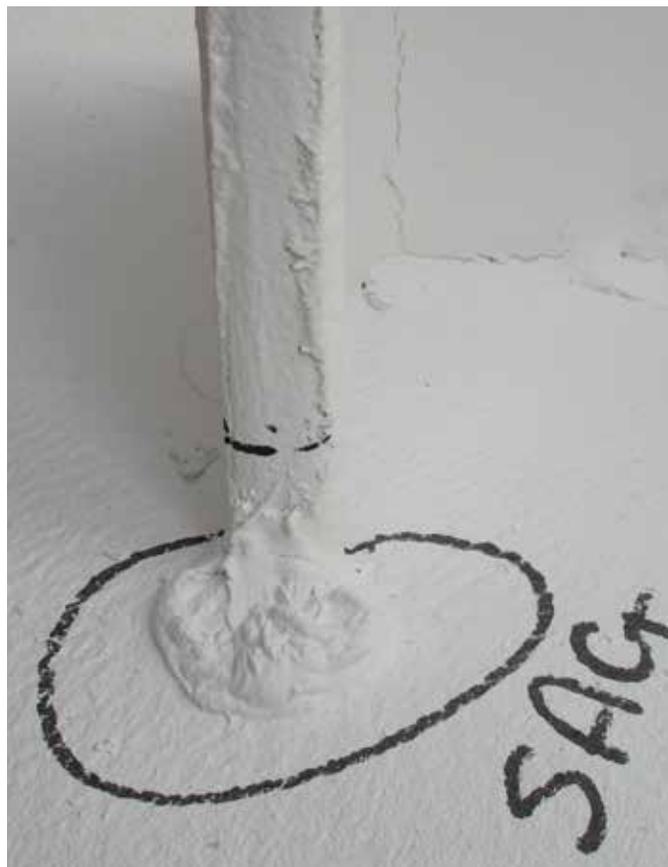
Slumping / sagging

- Product appears to 'sag' or 'slump' down
- Often, beads of paint pool and run down the surface

- Applied WFT much higher than recommended
- The product was thinned prior to use
- Applicator stood too close to the structure during application

- Nothing required from a fire-safety perspective — no detrimental effect on fire performance
- If superior aesthetics are required: sand to smooth surface

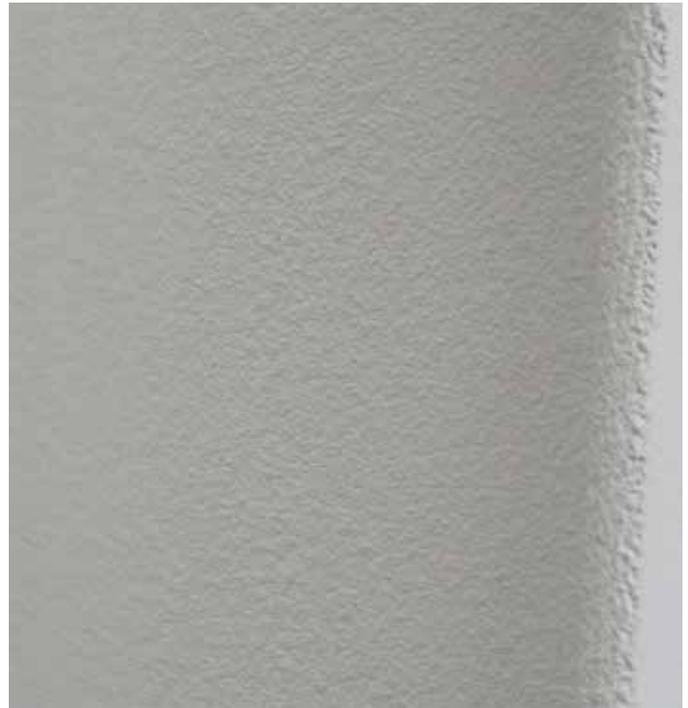
Dry spray

- Poor atomization of intumescent material

- Applicator stood too far from structure during application
- Application temperature too high

- Nothing required from a fire-safety perspective — no detrimental effect on fire performance
- Ensure you are at a correct spraying distance from the surface, and within product spray parameters
- If superior aesthetics are required: sand to smooth surface

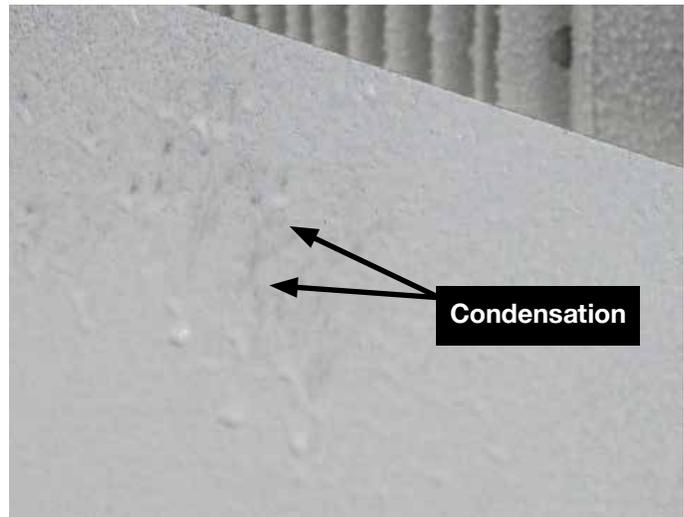
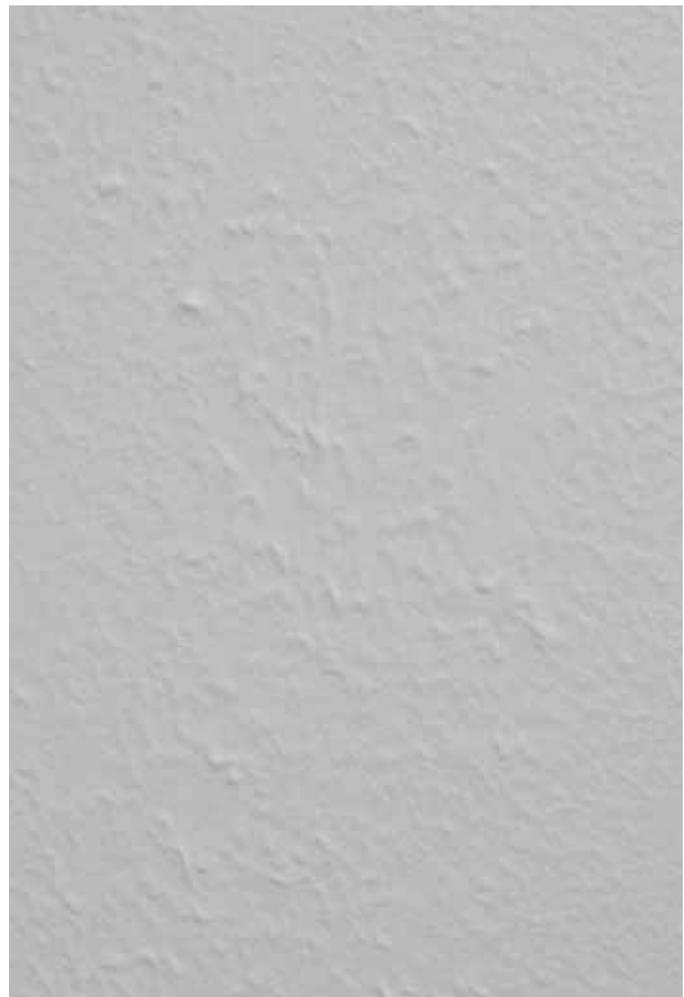
Poor hangability

- You are getting lower than expected wet film thicknesses

- Condensation / moisture on the steel surface
- Thinned product used
- Residual water in the spray pump

- Nothing required from a fire-safety perspective — no detrimental effect on fire performance
- Let the intumescent coating dry completely
- If superior aesthetics are required: sand smooth

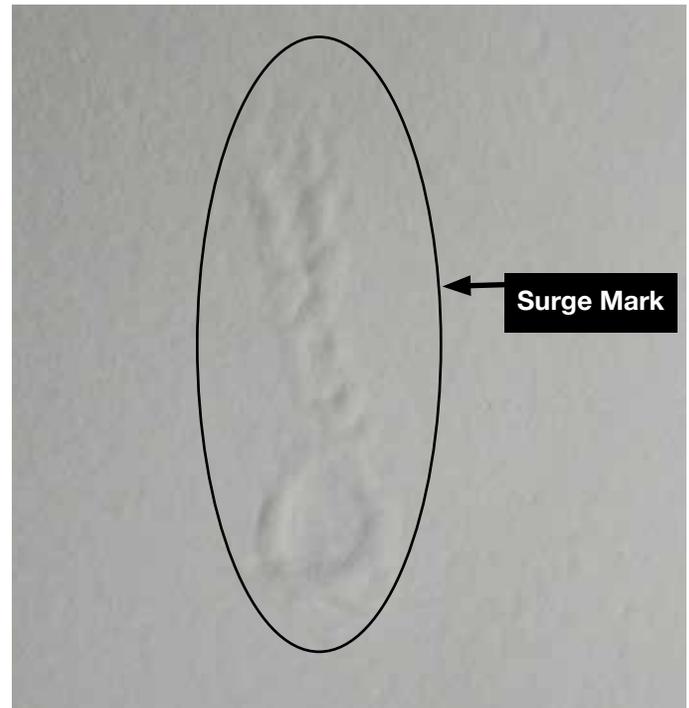
Surges

- Intumescent material that sprays out from pump in a stream vs. an atomized spray fan

- Cavitation of the pump
- Short tip blockage by foreign matter

- **Cavitation:** ensure sufficient level of intumescent in the pump feed
- No repairs required from a fire-safety perspective — no detrimental effect on fire performance
- If superior aesthetics are required: sand to smooth surface

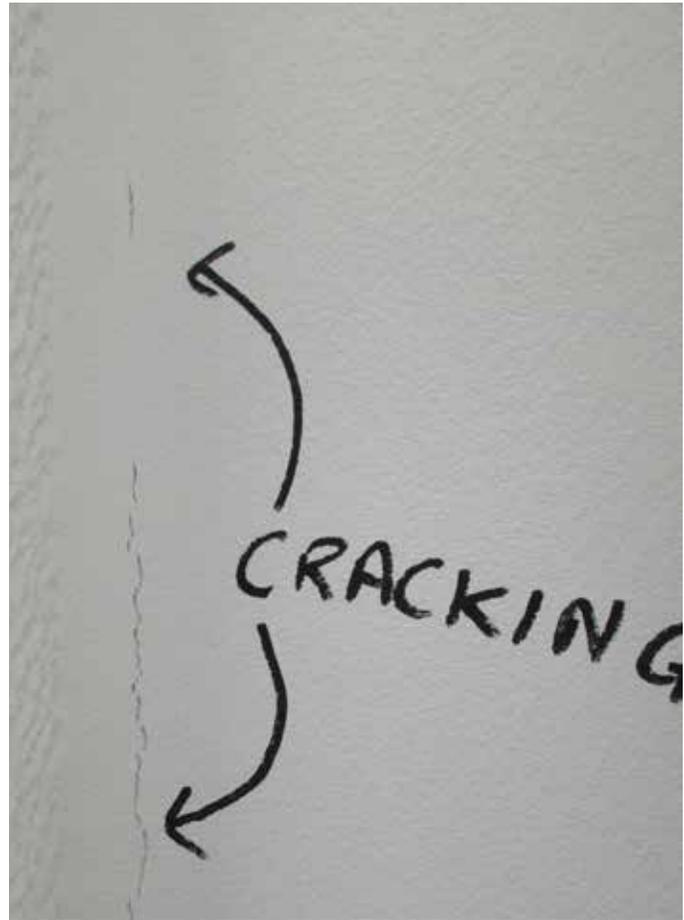
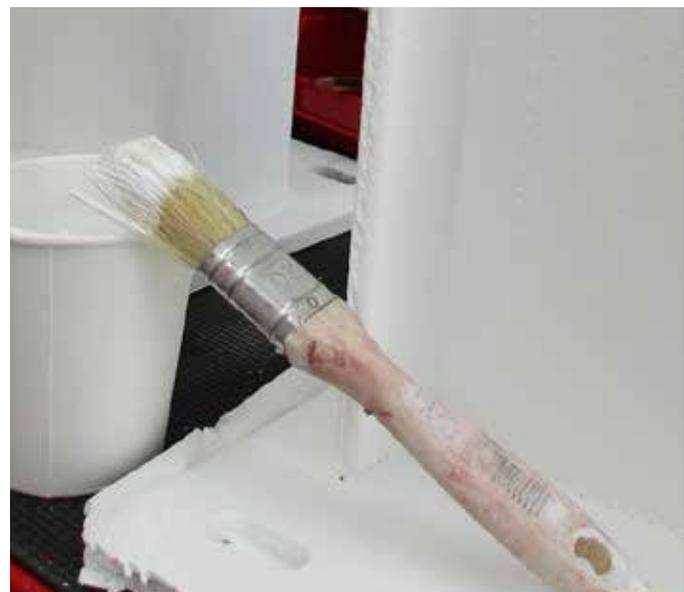
Cracks

- Physical cracks running through surface of material

- Higher than recommended WFT, high air flow, low humidity

- Application of a stripe coat can prevent crack formation if conditions exist that favor crack formation
- For hairline cracks — No repairs required from a fire-safety perspective — no detrimental effect on fire performance
 - All other cracks/gaps must be filled
- If superior aesthetics are required, apply a brush coat of material on top of the crack

Stripe coat can be brushed on to the steel member directly

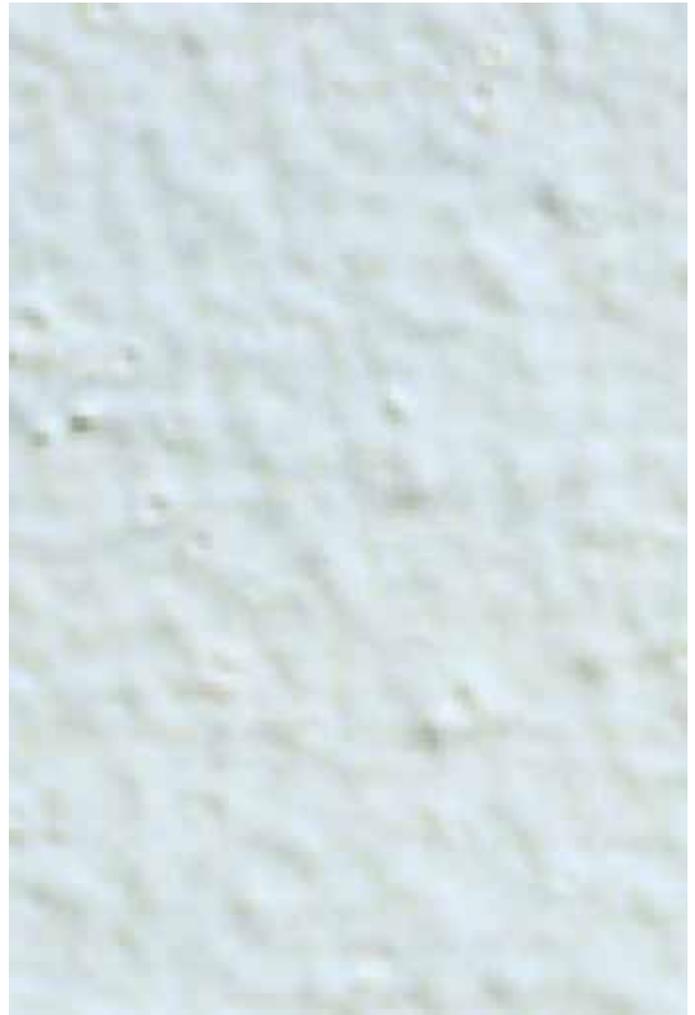
Pinholes

- Minor pinholes/craters in surface of product

- Poor atomization
- Air entrapment

- Check pump settings to ensure parameters are within product requirements
- Check tip for signs of wear, and when in doubt — change it
- No repairs required from a fire-safety perspective — no detrimental effect on fire performance
- If superior aesthetics are required: sand to smooth surface

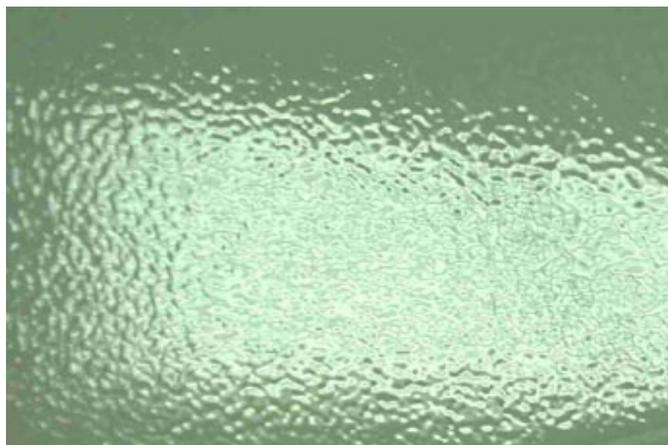
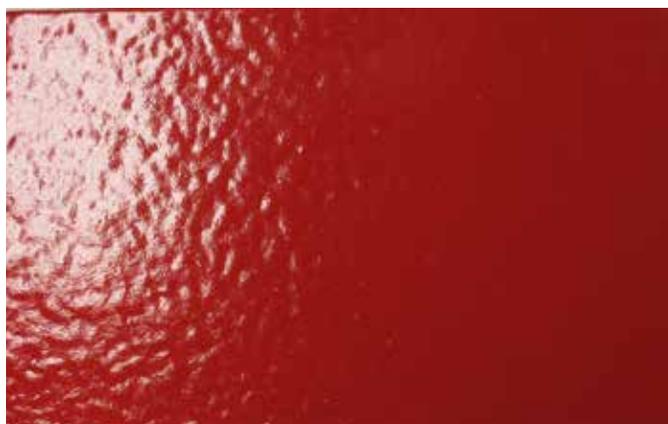
Orange Peel

- Rough textured appearance, similar to the peel of an orange, on the surface of the product

- Normal appearance for high build coatings
- High WFT have a propensity to orange peel
- High gloss top coat exacerbates the appearance

- No repairs required from a fire-safety perspective — no detrimental effect on fire performance
- If superior aesthetics are required: sand to smooth surface

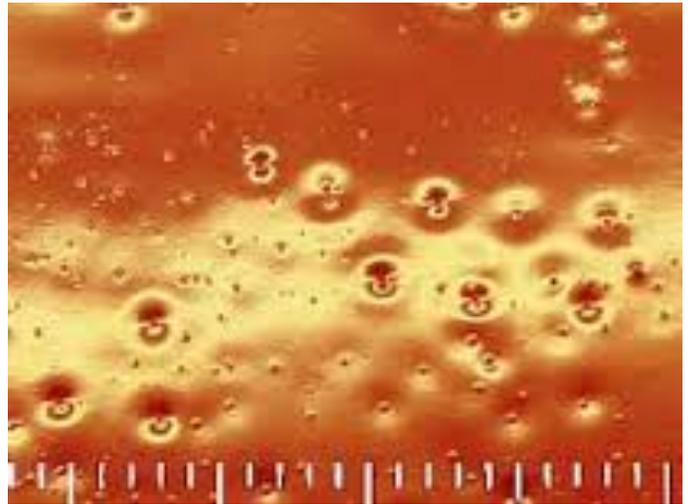
Cratering (top coats only)

- Pock-marked top coat

- Defect in the top coat caused by foreign matter
- Frequently observed with polyurethane and silicone top coats
- NOT a problem of the intumescent

- Ensure that top coat is properly mixed. When in doubt, filter the top coat
- Contact your topcoat manufacturer for continued issues
- No repairs required from a fire-safety perspective — no detrimental effect on fire performance
- If superior aesthetics are required: smooth top coat and re-apply a thin layer

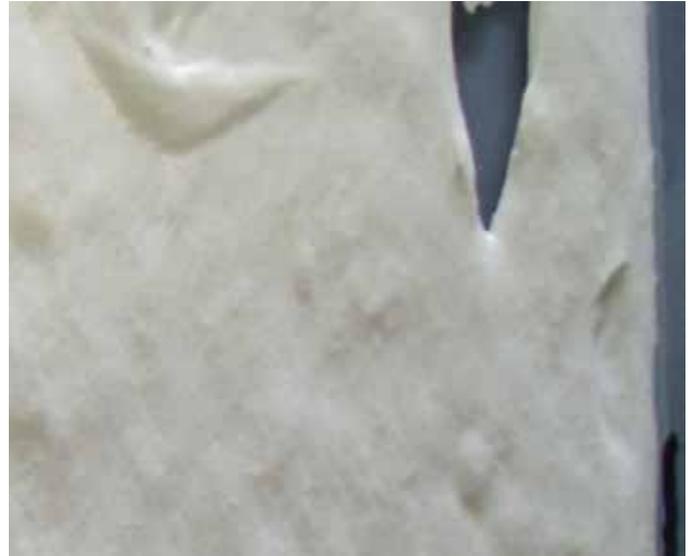
Product not adhering to the substrate

- The spray product does not adhere to the substrate — slides off during the initial spraying/drying process

- The primer may not be compatible, or the product was applied outside of the specified recoat window (of its primer)
- Contamination of substrate (oil, grease, ...)

- The Fire Finish product **MUST** be removed completely from the steel member
- Check primer compatibility
 - Remove incompatible primer
 - Re-blast steel and apply approved primer
- Remove contamination
 - De-grease, water jet, ...
 - Re-apply Fire Finish as per UL requirements

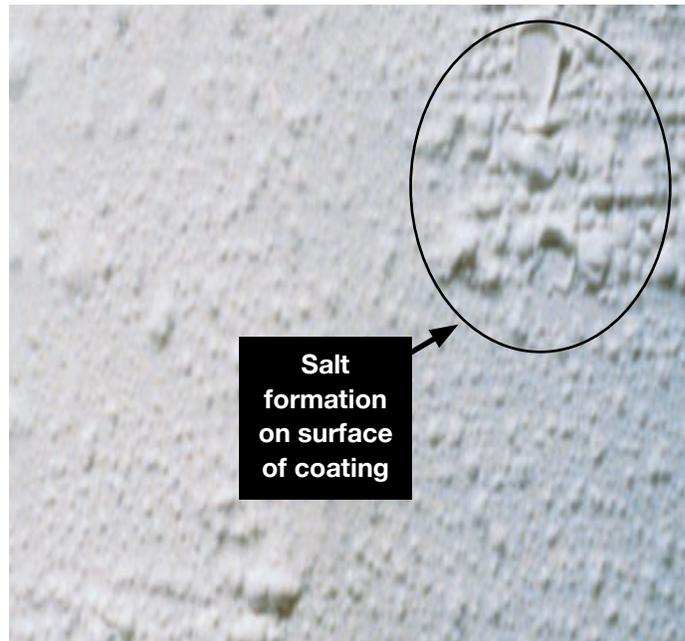
Efflorescence

- Looks like there is 'salt formation' on the surface of the material

- Entrapment of water-vapor
- Exposure to water or non-interior use conditions

- The Fire Finish product **MUST** be removed completely from the steel member and reapplied
 - No way to repair the material — fire performance has been compromised

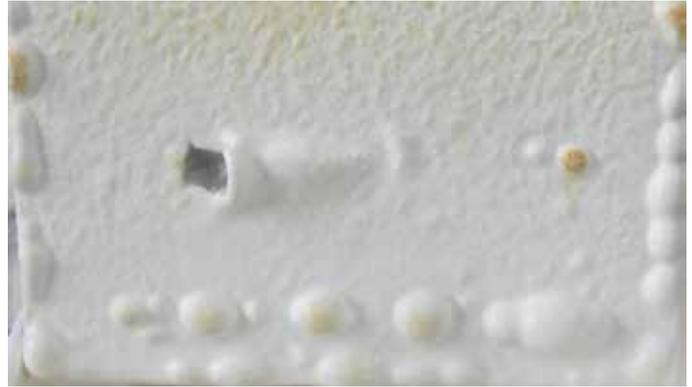
Blistering

- Surface of the material seems to have ‘blisters’ on it

- Exposure to pooling / standing / running water

- The Fire Finish product **MUST** be removed completely from the steel member and reapplied
 - No way to repair the material — fire performance has been compromised

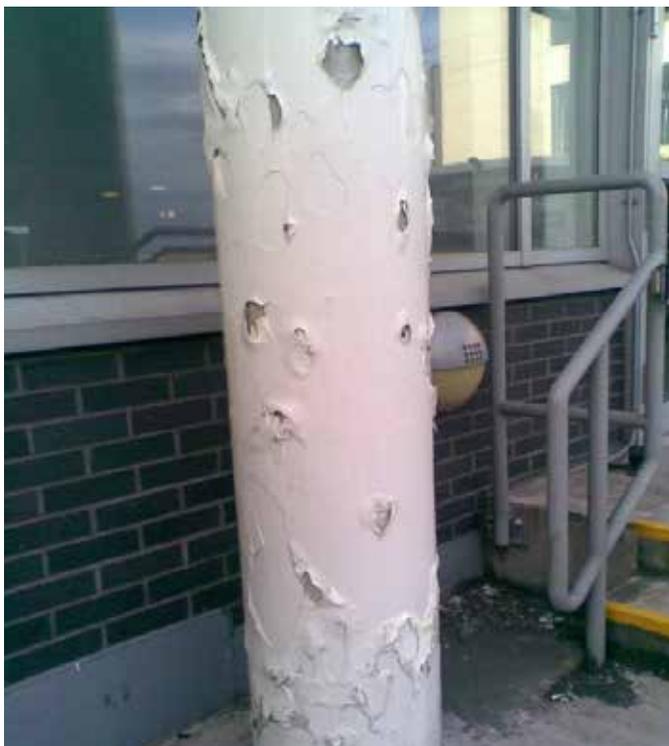
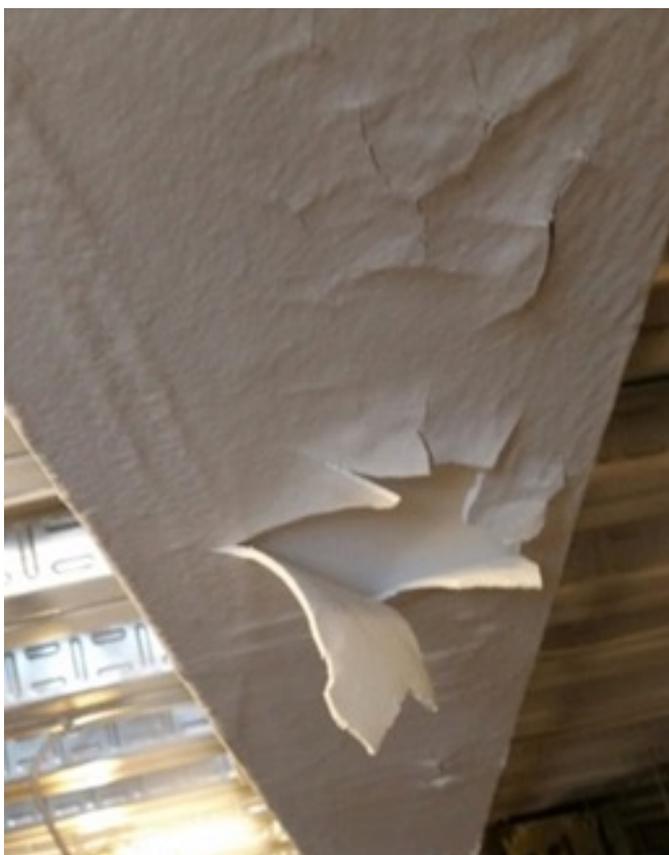
Delamination

- Product delaminates off the steel structure after it is dry

- Product applied over incompatible surface or primer
- Contamination of substrate or product
- Moisture ingress over time

- The Fire Finish product and base Primer MUST be removed completely from the column and reapplied
 - No way to repair the material — fire performance has been compromised
- Re-apply after blast cleaning and priming the steel with an approved primer

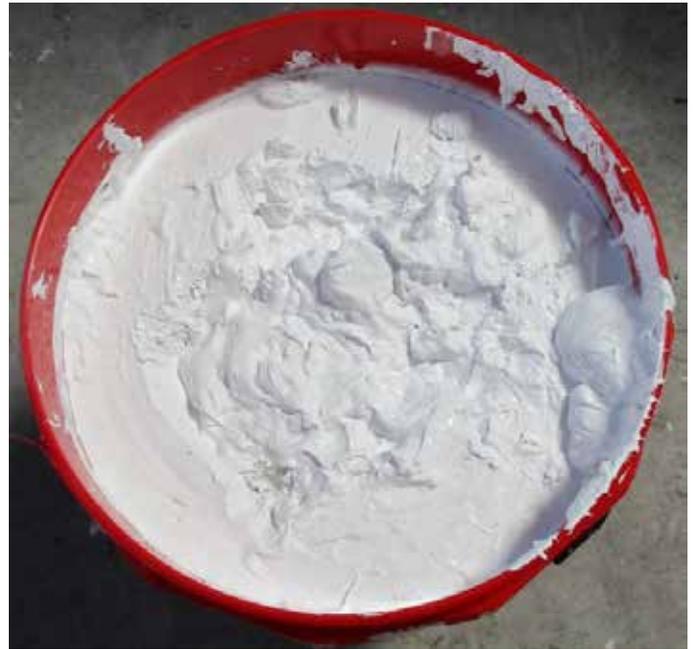
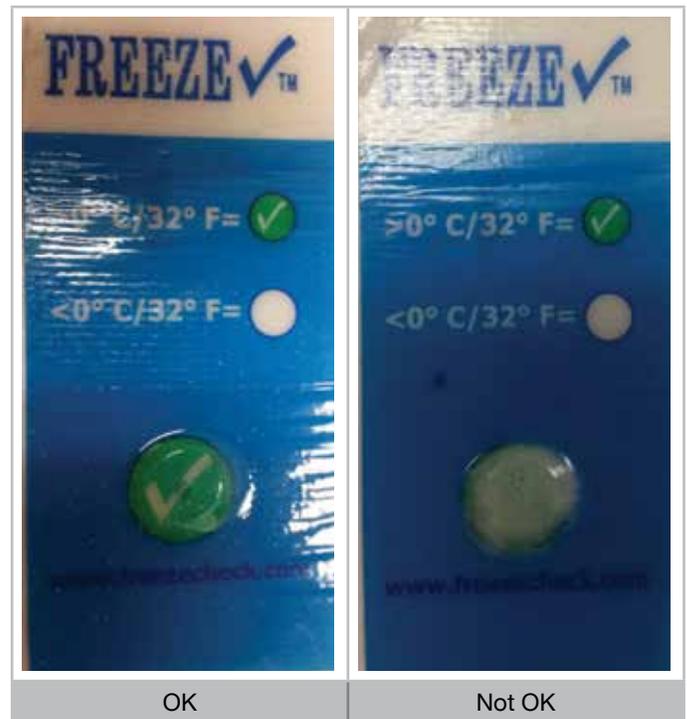
Frost damage of the wet coating

- Coagulated product that can not be stirred up

- The product has been frozen and subsequently thawed

If the Check Mark on the label is obscured, then the product has been previously frozen.

- DO NOT USE: Dispose of complete bucket if freeze indicator is activated
