#### **SOUND TRANSMISSION LOSS TEST REPORT NO. TL20-406**

CLIENT: Hilti 17 August 2020

TEST DATE: 29 July 2020

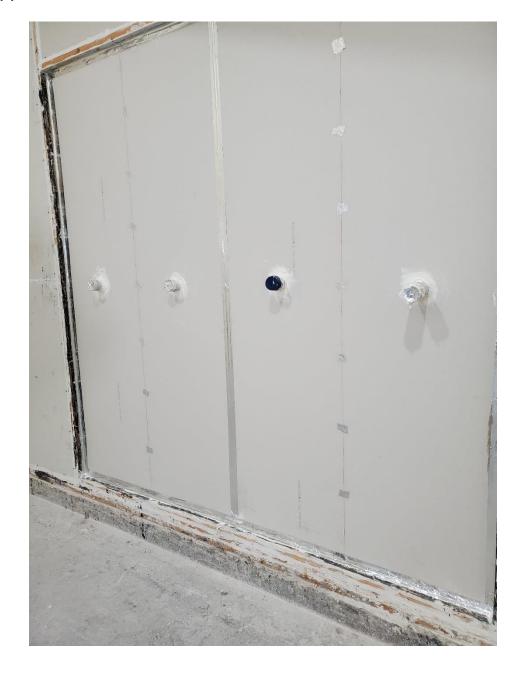
### PHOTO(S) OF TEST SPECIMEN

- A total of four (4) steel pipes with an outer diameter (O.D.) of 59 mm (2-3/8 inch) were installed in the center of the stud bays, one (1) pipe in each stud bay. A 13 mm (1/2 inch) joint was left around the pipe and was sealed with Hilti CS-S SA LIGHT Smoke and Acoustic sealant. The pipes were installed using plumber's tape metal strapping looped around the pipe to suspend it in the center of the stud bay. 6 mm (1/4 inch) felt was used to isolate the pipe from the strapping. The pipe was packed with mineral wool insulation, capped on each side, and extended a total of 102 mm (4 inches) past the face of the gypsum board. See photos for conditions.

The test specimen consisted of a double steel stud wall assembly with Type 'X' gypsum board installed on both sides of the panel, batt insulation in the stud cavity, and a total of four (4) steel pipes with an outer diameter (O.D.) of 59 mm (2-3/8 inch) installed in the center of the stud bays, one (1) pipe in each stud bay. A 13 mm (1/2 inch) joint was left around the pipe and was sealed with Hilti CS-S SA LIGHT Smoke and Acoustic sealant. Additional information regarding pipe installation provided in the details below.
