STC Table: Head-of-Wall Sound Assemblies with CFS-TTS MD Top Track Seal										
Stud Framing	Top Track	Wall Assembly	Joint Filler	Small Notch Filler	Joint Width	Metal Deck Height	Baseline STC*	Tested STC		
3-5/8" 25-ga steel (24 in/OC)	20-ga slotted slip track	1 layer - 5/8" Type X gypsum each side	CFS-TTS MD Top Track Seal & P3 Flute Plugs	Sliver of TTS MD on both sides	1"	3"	49 TL20-224	49 TL20-223		
	slotted slip				CFS-TTS MD Top Track Seal & P3 Flute Plugs	Sliver of TTS MD on one side	1"	3"	54 TL20-491	51 TL20-485
			CFS-TTS MD Top Track Seal & P3 Flute Plugs	Sliver of TTS MD on both sides	1"	3"	54 TL20-491	52 TL20-484		
		2 layers - 5/8" Type X gypsum each side	CFS-TTS MD Top Track Seal & P3 Flute Plugs	CP 506 on one side	1"	3"	54 TL20-491	52 TL20-486		
3-5/8" 25-ga steel (24 in/OC)			CFS-TTS MD Top Track Seal CP 506 on both		1"	3"	54 TL20-491	52 TL20-487		
			CFS-TTS MD Top Track Seal & P3 Flute Plugs	Open	1"	3"	54 TL20-491	45 TL20-479

## SOUND TRANSMISSION LOSS TEST REPORT NO. TL20-224

## SOUND TRANSMISSION LOSS TEST REPORT NO. TL20-491

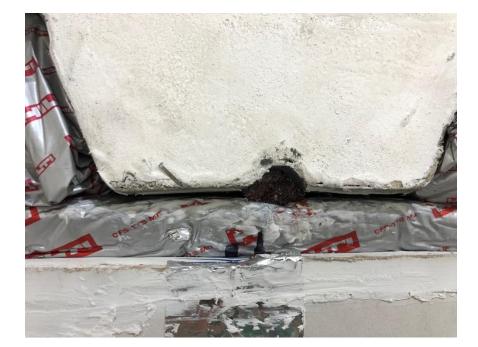
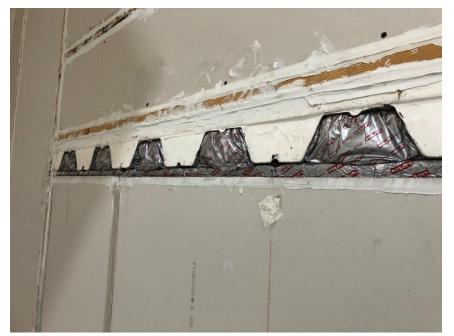
#### PHOTOS OF TEST SPECIMEN

- The top 152 mm (6 inches) of the wall assembly was constructed to mimic a metal deck structure with flute openings exposed on both sides.
  - The head-of-wall joint where the gypsum board terminated at the top track was 13 mm (1/2 inch) in size and was sealed with Hilti CFS-TTS MD TTS Firestop Top Track Seal.

- The flute openings that were exposed were filled Hilti CFS-TTS MD P FS Top Track Plugs, which are trapezoidal foam bricks which fill the openings.
  - Small corrugations in the metal decking filled with small pieces of Hilti CFS-TTS-MD on one side. All products were installed per manufacturer's instructions.

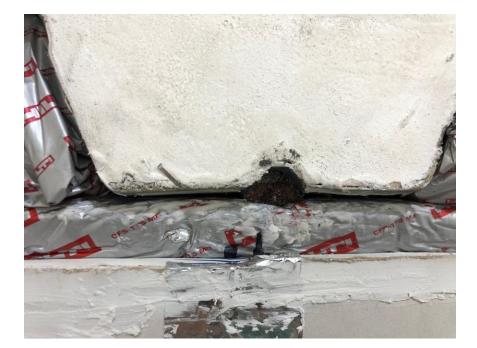
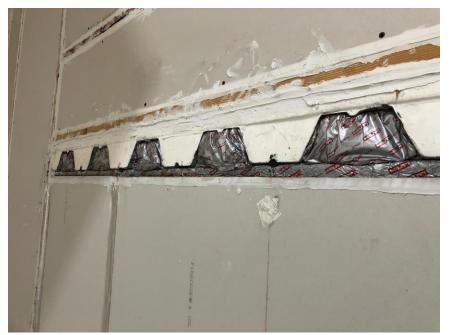
### PHOTOS OF TEST SPECIMEN

The test specimen consisted of a single steel stud wall assembly with Type 'X' gypsum board installed on both sides of the panel and batt insulation in the stud cavity. The top of the wall assembly mimicked a concrete metal deck structure, and the framing was mounted to it. Atop the track, the Hilti CFS-TTS MD Firestop Top Track Seal was installed to seal the head-of-wall joint. The large flute openings of the metal deck were filled with Hilti CFS-TTS MD P FS Top Track Plugs. The small flute openings of the metal deck were filled with small pieces of Hilti CFS-TTS-MD on both sides.
