HEPA VACUUM TEST REPORT

Models: VC20U, VC40U, VC40U /outlet

HEPA LEAK TESTING OF HILTI HEPA VACUUM UNITS BENCH TESTING FOR AEROSOL PENETRATION

VACUUM CLEANER

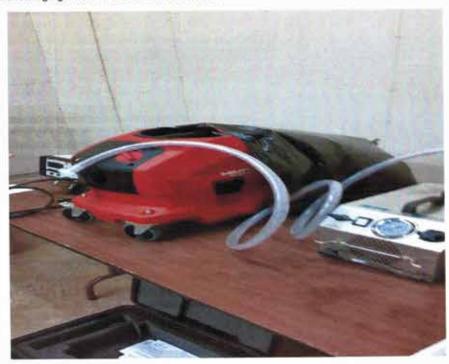
Each Vacuum is setup with an internal prefilter bag placed in the base of the bucket and a HEPA filter placed below the motor

Airflow enteres the intake and is them passed through the prefilter bag and then is siphoned up throu the HEPA filter and then discharged

A large bag was placed over the outlet side of the Vacuum unit

The Intake airflow was measured with a Velocity meter set for CFM Calculation (135 CFM)

A calculated concentration was followed using an aerosol challenge for >10 microbrams per liter of PAO Aerosol The Aerosol Photometer was set at a sensitivity of 50 micrograms, and the test proceeded by insertion of aerosol in the intake and sampling the outflow of the air filling the collection bag.

No leakage greater than .005% was detected

Test Setup showing Aerosol Generator on right HILTI VC20U Vacuum in middle with catch bag attached, and Aerosol Photometer on the left
